ONLINE INFORMATION

Maritime Electric Cumberland St Main Plant

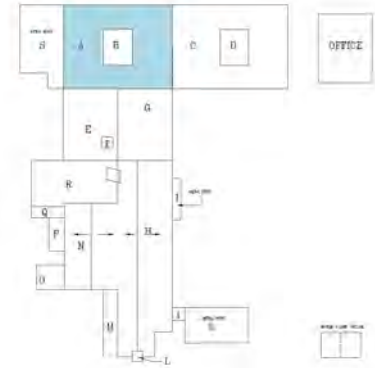
**ROOF COMPOSITION**

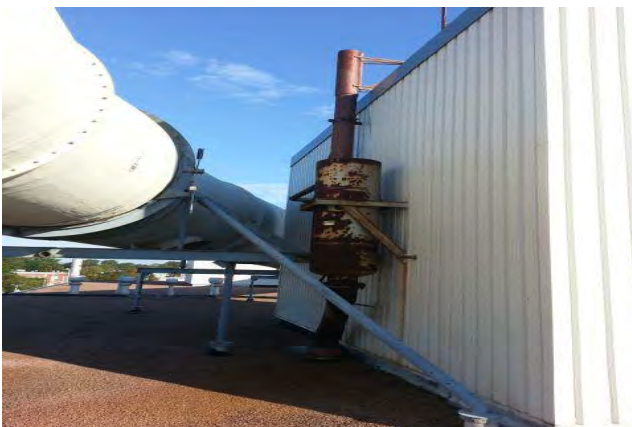
North west corner chimney unit is corroding.

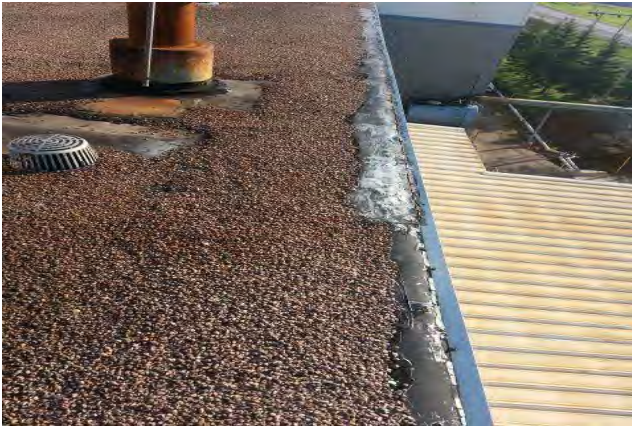
South perimeter gravel stop caulking requires attention.

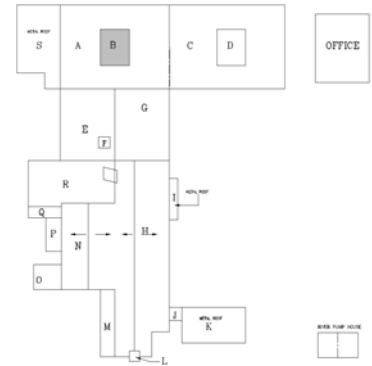
Roof Name B
Service Activity Type Thermocore
Service Activity Date September 04, 2014
Roof Leaks No
Roof Size 820 sq. ft.
76.21 sq. meters
Roof Type BUR Gravel Surface
Replacement Cost \$18,040.00
Roof Rating No Condition Recorded

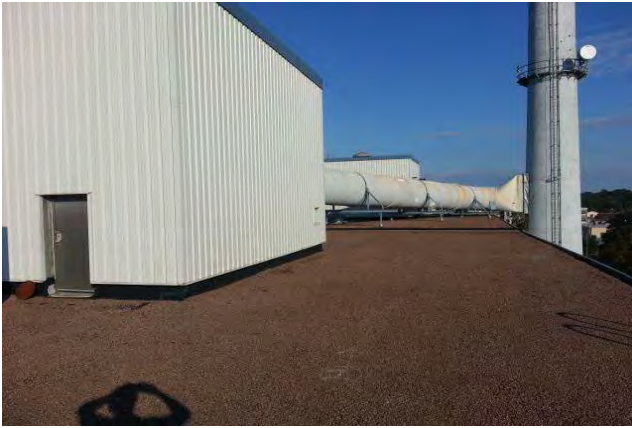
Penthouse roof view. Not currently ladder accessible.

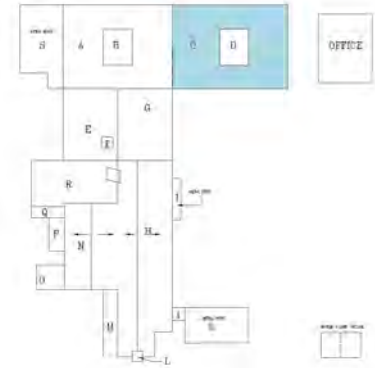
**ROOF COMPOSITION**

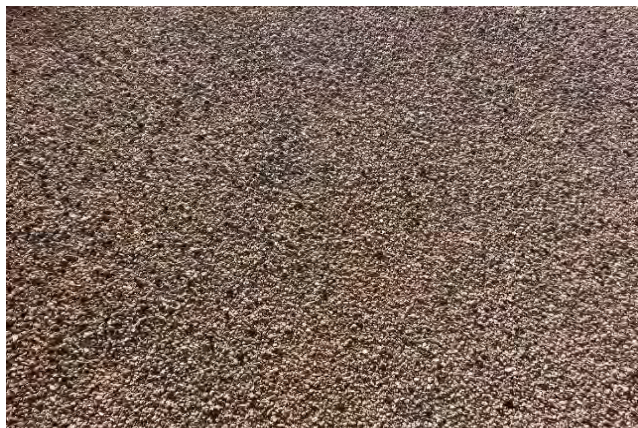
Blueberries identified on roof surface. They are formed when water penetrates the top flood coat of asphalt. Freeze-thaw cycling breaks pieces of the flood coat loose allowing wind and the elements to move these pieces around until they are eroded to a spherical shape resembling small blueberries. Subsequently, water flow causes them to accumulate in low spots on the roof. Blueberries indicate there are areas of the surfacing asphalt that have degraded and thus broken from the surface. This can lead to subsequent bare spots and accelerated roof system degradation.

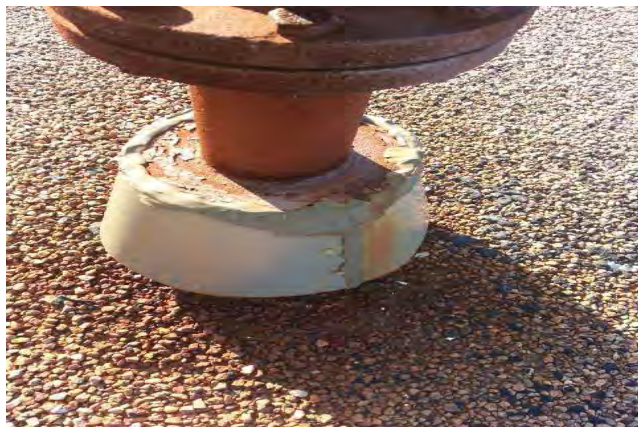
Blueberries identified on roof surface. They are formed when water penetrates the top flood coat of asphalt. Freeze-thaw cycling breaks pieces of the flood coat loose allowing wind and the elements to move these pieces around until they are eroded to a spherical shape resembling small blueberries. Subsequently, water flow causes them to accumulate in low spots on the roof. Blueberries indicate there are areas of the surfacing asphalt that have degraded and thus broken from the surface. This can lead to subsequent bare spots and accelerated roof system degradation.

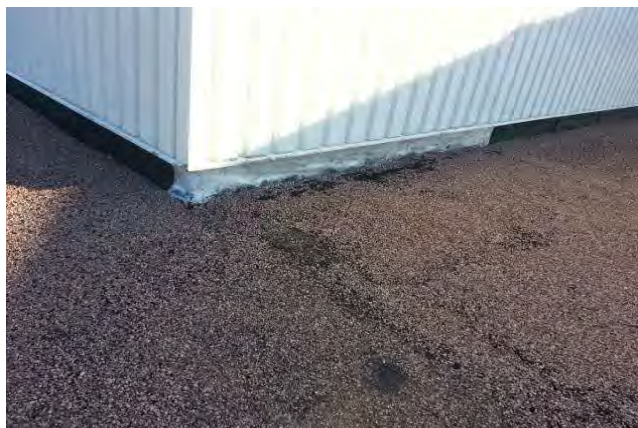
Penthouse flashing detail is very low. Proper flashing detail should be minimum 8in above roof surface.

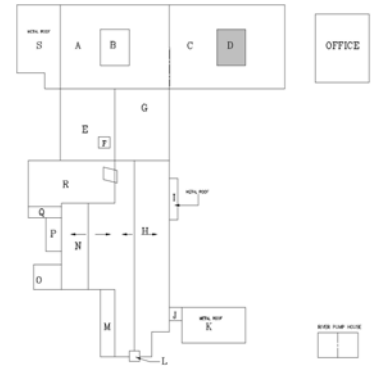
Roof Name D
Service Activity Type Thermocore
Service Activity Date September 04, 2014
Roof Leaks No
Roof Size 820 sq. ft.
76.21 sq. meters
Roof Type BUR Gravel Surface
Roof Rating No Condition Recorded

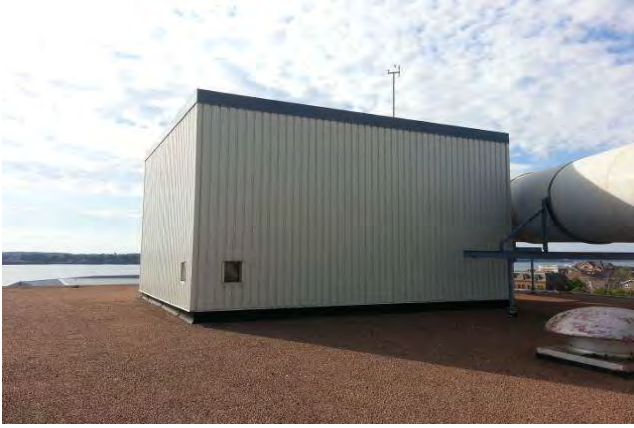
Roof view. No ladder access to roof unit.

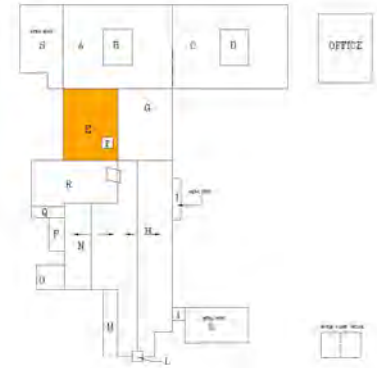
**ROOF COMPOSITION**

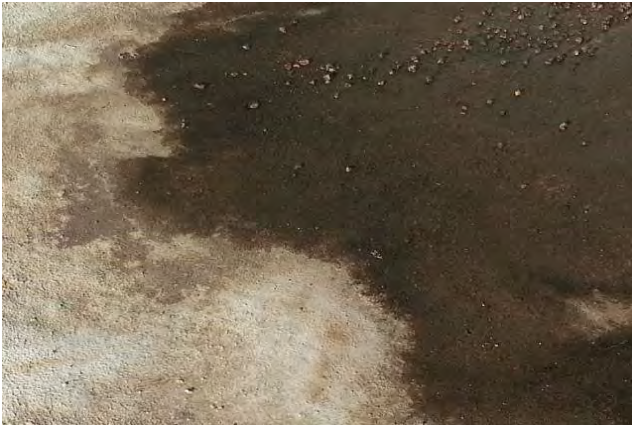
Noticeable staining and granular loss on modified bitumen membrane.

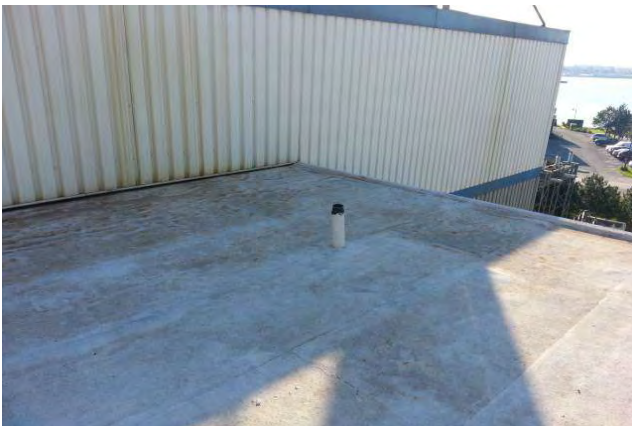
Visible granular loss on roof membrane.

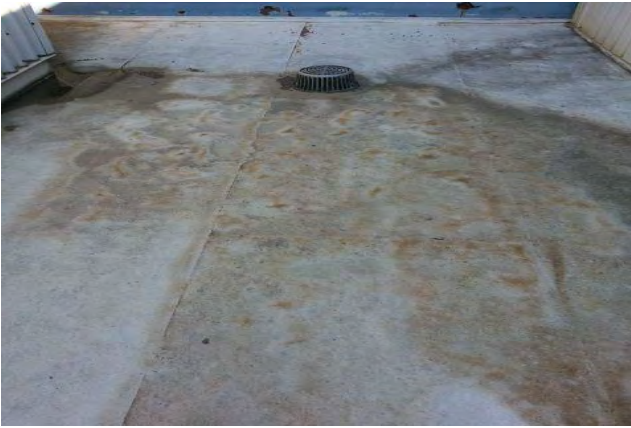
Noticeable staining and granular loss on modified bitumen membrane near roof drain.

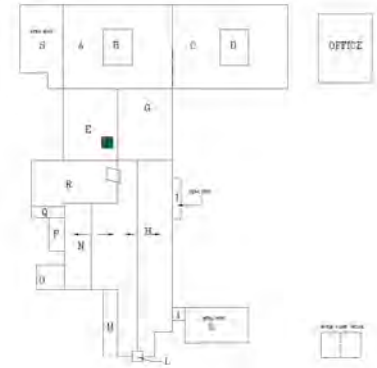
**ROOF COMPOSITION**

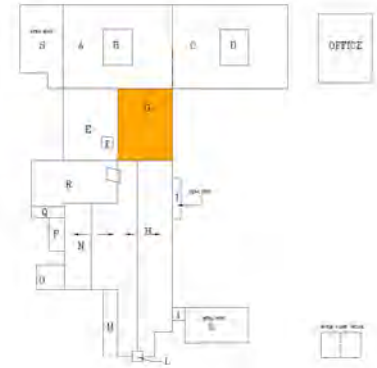
**ROOF COMPOSITION**

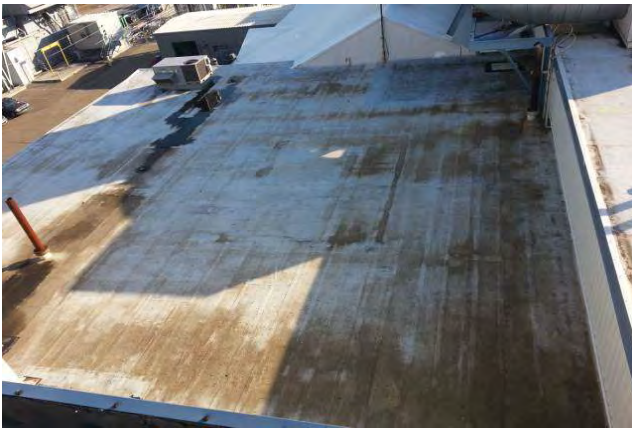
Roof view. Visible staining and granular loss on roof membrane.

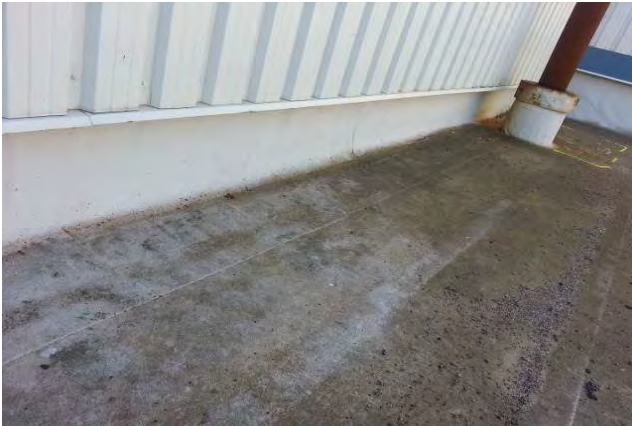
Visible staining and granular loss on roof membrane.

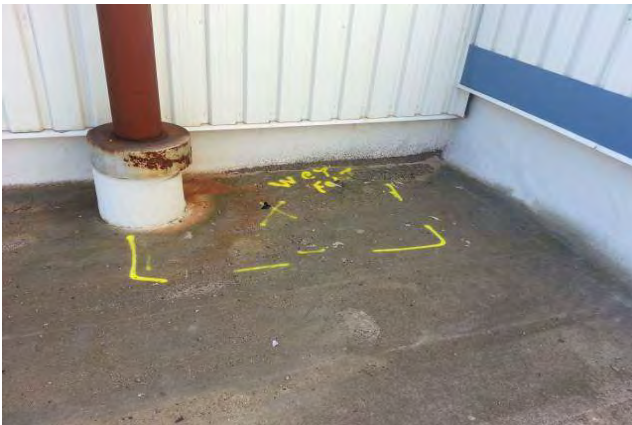
Thermal scan identified @ 10 sq ft of wet felts within roof area.

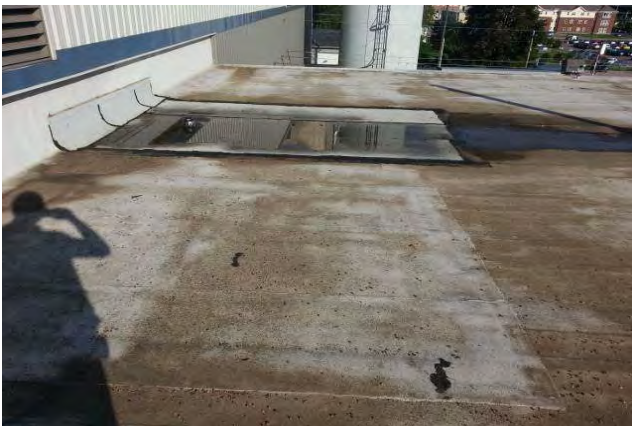
Visible ponding water overtop previous roof repair.

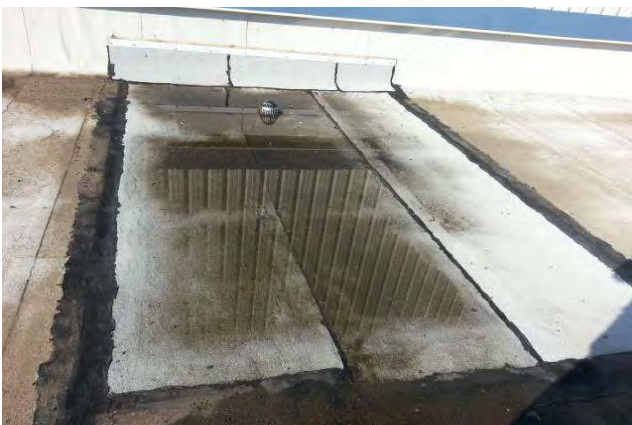
Visible ponding water overtop previous roof repair.

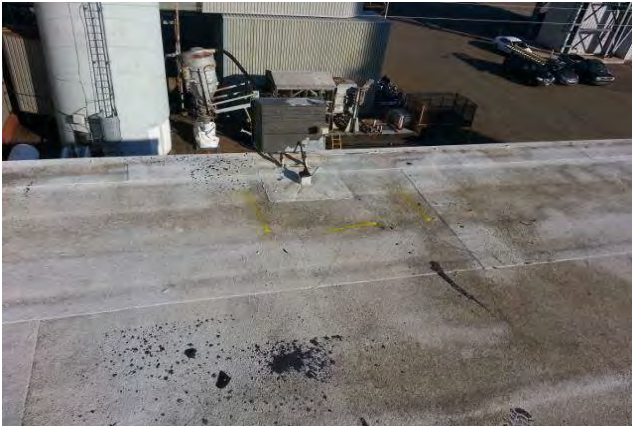
Thermal scan identified @9 sq ft of wet within system. Fall arrest work plan will be necessary.

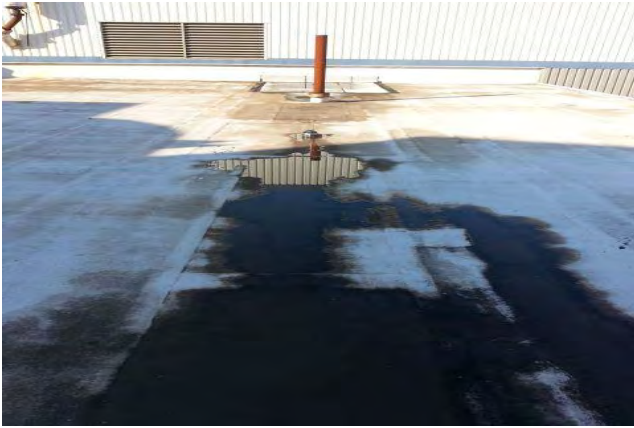
Noticeable staining and granular loss on modified bitumen membrane near roof drain.

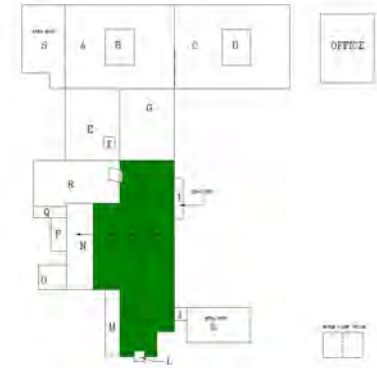
**ROOF COMPOSITION**

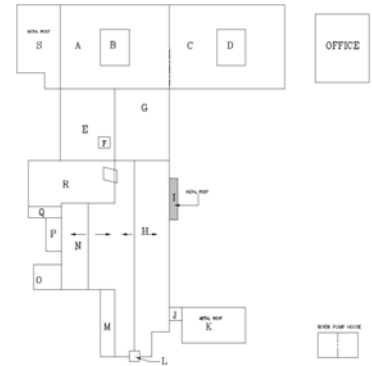
Roof Name I
Service Activity Type Thermocore
Service Activity Date September 04, 2014
Roof Leaks No
Roof Size 296 sq. ft.
27.51 sq. meters
Roof Type Metal
Roof Rating No Condition Recorded

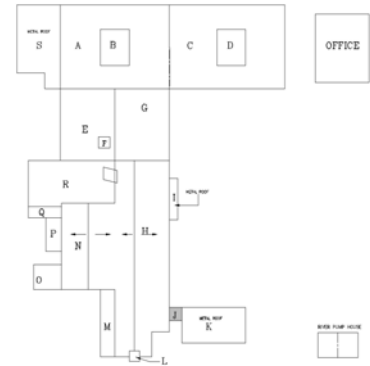
**ROOF COMPOSITION**

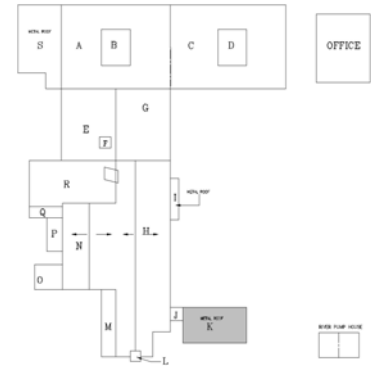
**ROOF COMPOSITION**

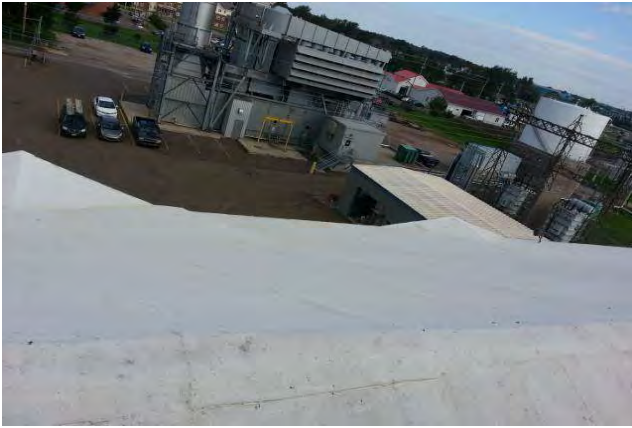
Roof view. No condition recorded. No access to roof area.

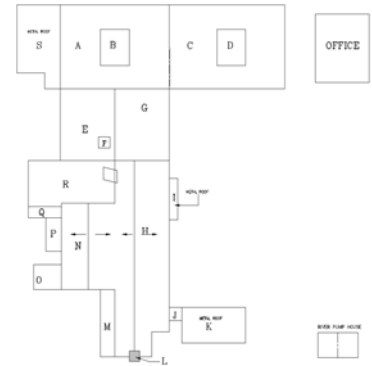
Roof Name L
Service Activity Type Thermocore
Service Activity Date September 04, 2014
Roof Leaks No
Roof Size 92 sq. ft.
8.55 sq. meters
Roof Type Modified Bitumen
Roof Rating No Condition Recorded

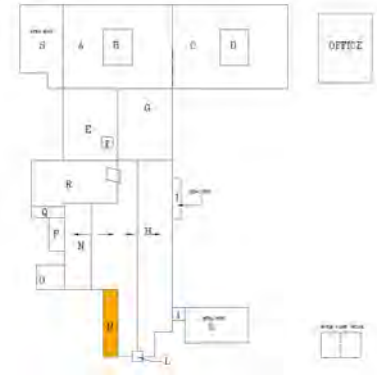
**ROOF COMPOSITION**

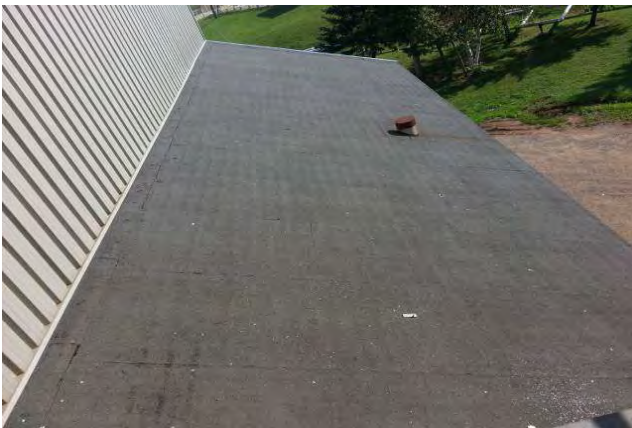
Roof membrane is in poor condition. No granular surface visible.

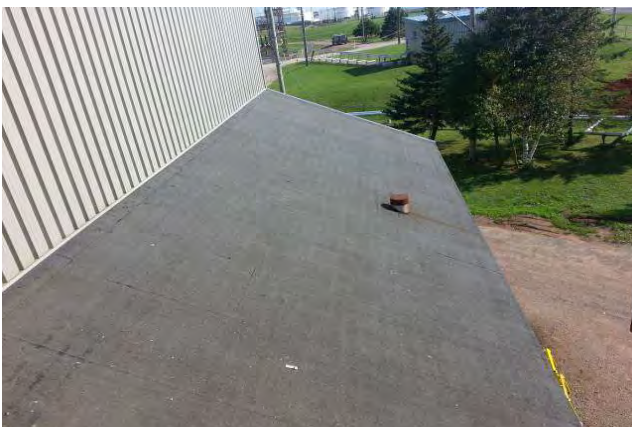
Roof membrane is in poor condition. No granular surface visible.

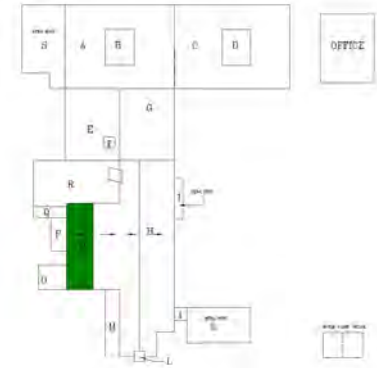
**ROOF COMPOSITION**

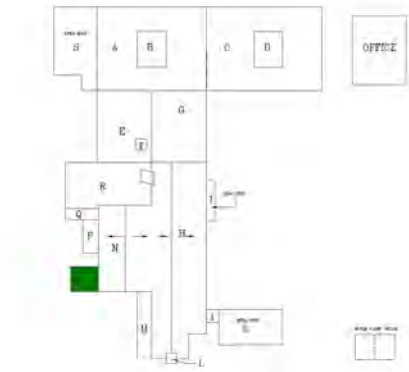
**ROOF COMPOSITION**

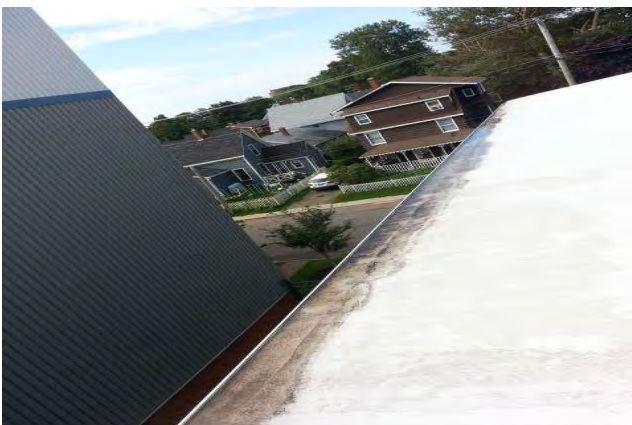
Poor quality drip edge detail affecting exterior drainage system. Deteriorating restorative coating at roof perimeter.

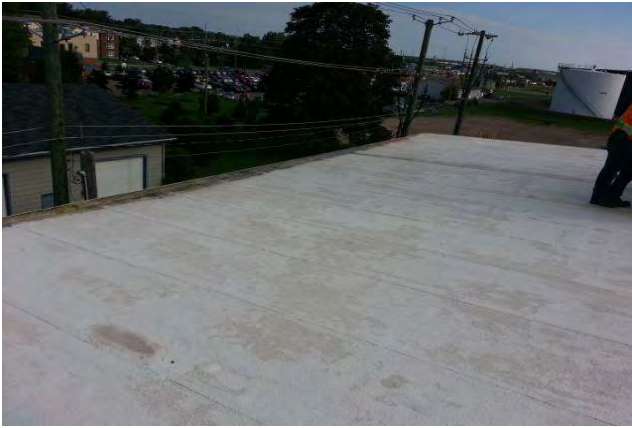
Poor quality drip edge detail affecting exterior drainage system. Deteriorating restorative coating at roof perimeter.

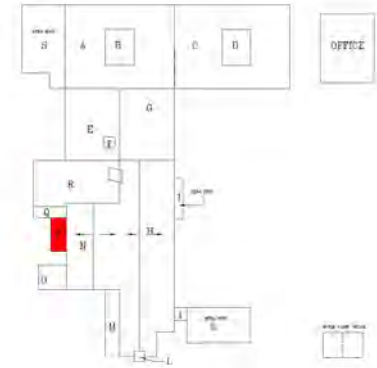
**ROOF COMPOSITION**

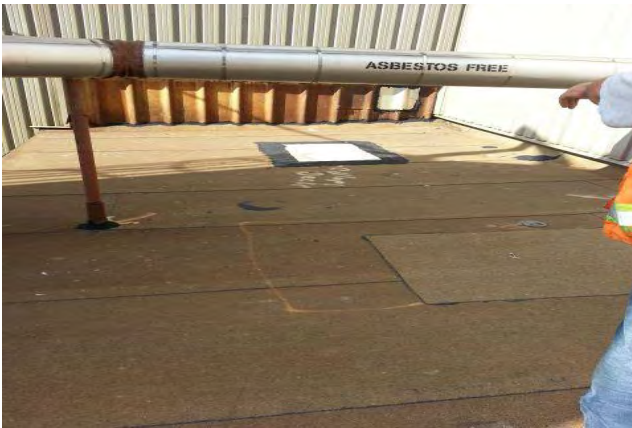
Roof view. Previous repairs visible.

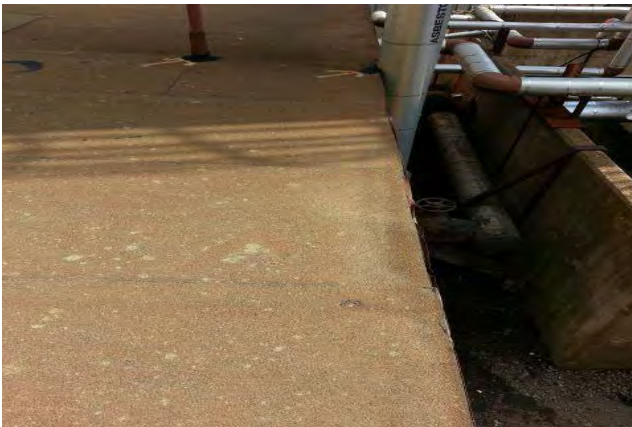
Roof gravel stop detail is completely deteriorated. Water can infiltrate roof system.

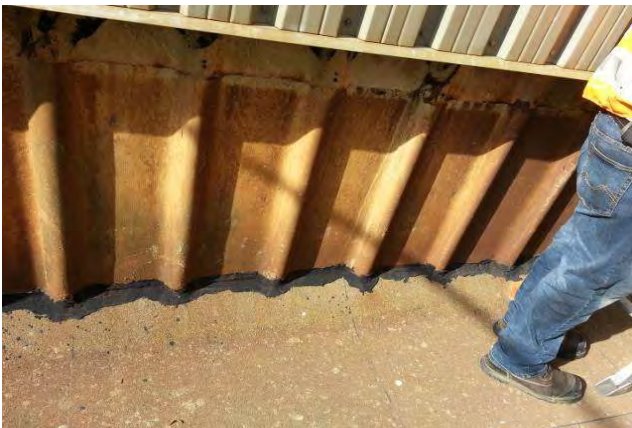
Poor flashing detail at South wall. Low flashing height and mastic is deteriorating.

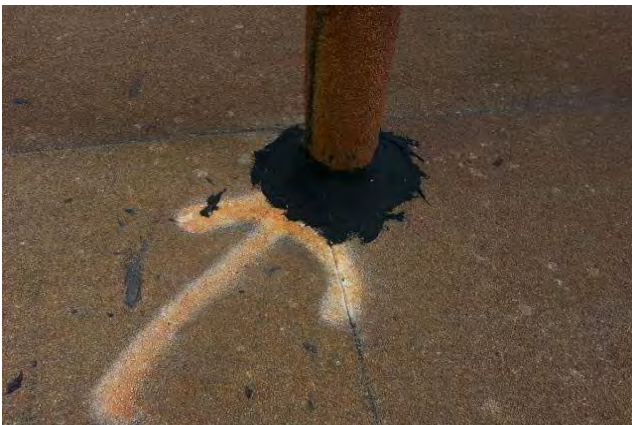
Mastic at soil stack needs to be addressed.

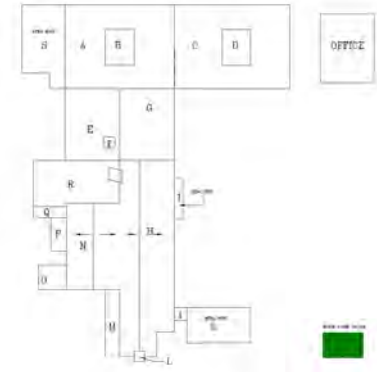
**ROOF COMPOSITION**

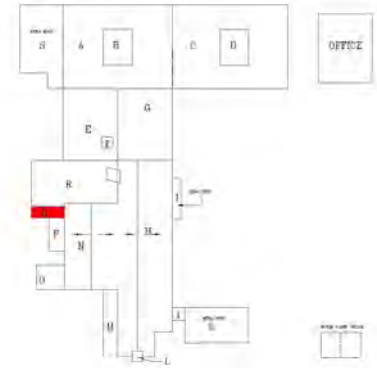
**ROOF COMPOSITION**

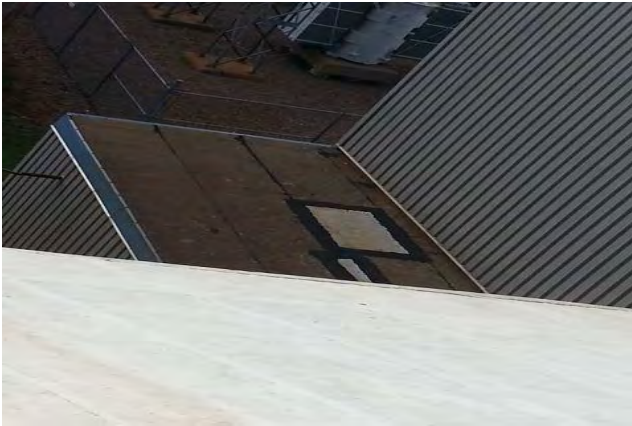
Roof view. Previous repairs are visible.

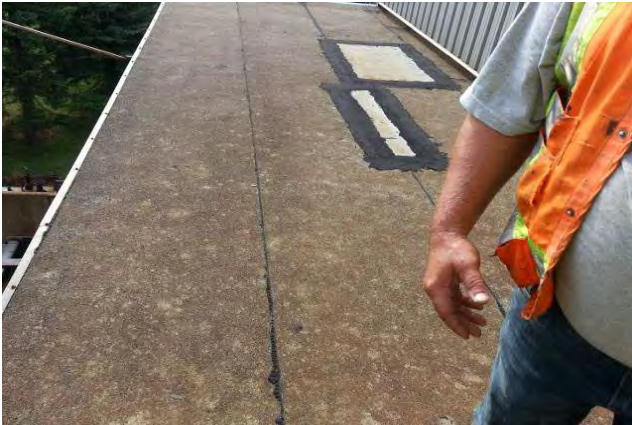
Roof view. Previous repairs are visible.

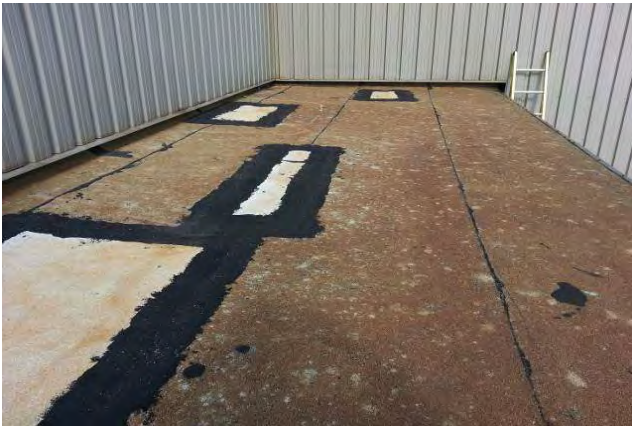
Roof view. Previous repairs are visible.

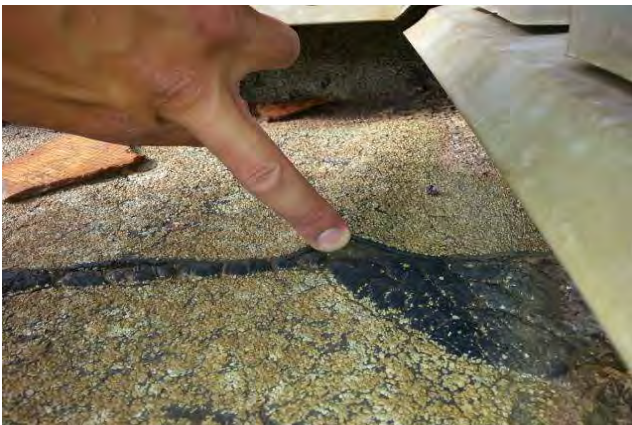
Open lap seam at perimeter.

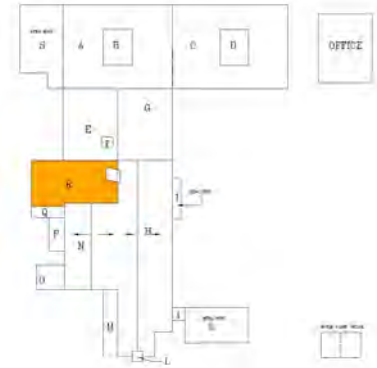
**ROOF COMPOSITION**

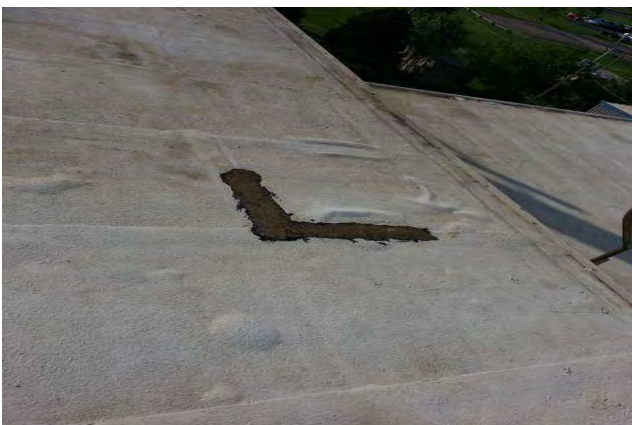
Previous roof repair is visible.

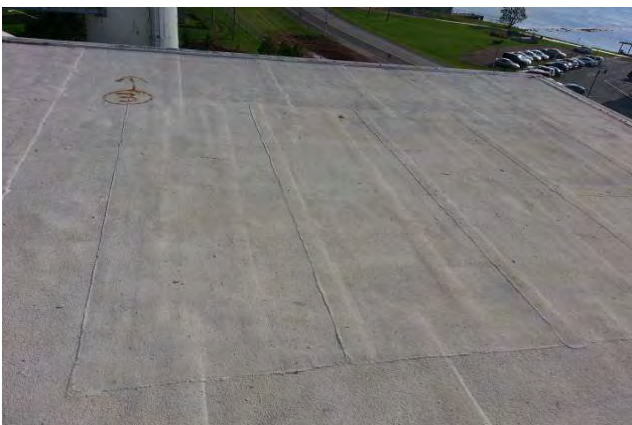
Previous roof repair is visible.

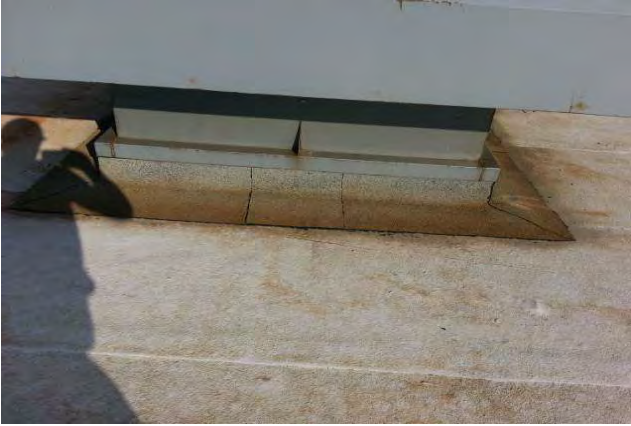
Low flashing height at curb unit. Proper flashing detail is minimum 8in above roof surface.

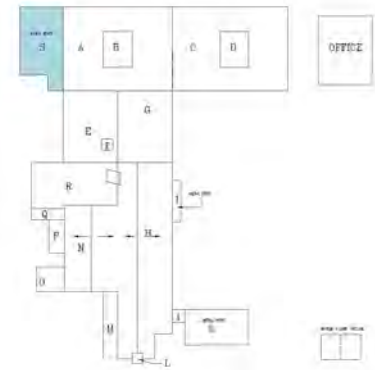
**ROOF COMPOSITION**

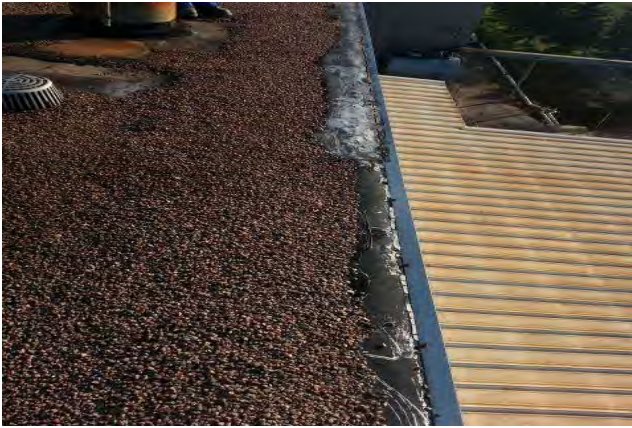
Roof view. Some corrosion visible on metal roof membrane.
