Asbestos Inventory

Maritime Electric
Generating Station

Revision #2 – February 19, 2014
Revised asbestos inventory to
present state.

Charlottetown Thermal Generating Station - Asbestos Inventory

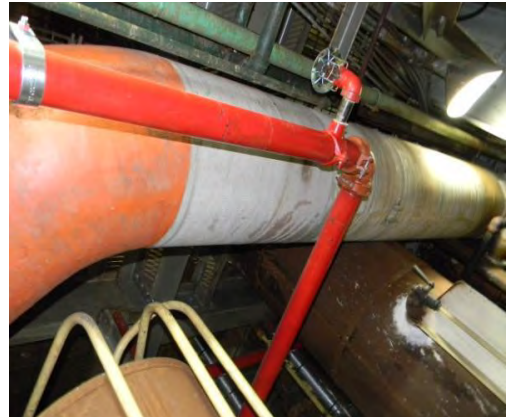
Mechanical Friable Pipe ACM								Site Photo
Photo No.	Pipe ID#	Location / Grid ID	Design ID / colour	Approx. diameter	Approx. Length (l.f)	Re-Insulate (Yes/No)	Asbestos Content	
1	p-001	No. 10 Turbine - 1st platform elevation / KL-89	HP Steam Pipe insulation (metal cladding with orange fittings)	18"	50	Yes	Ref: ME-069 80% Amosite

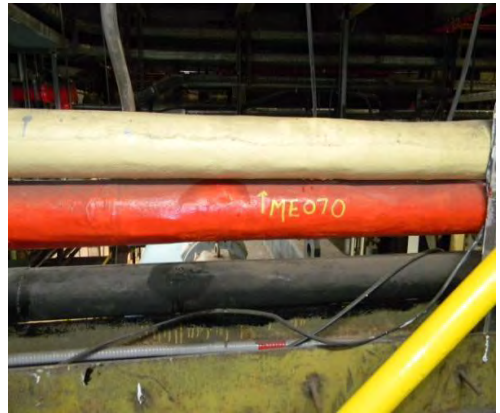
2	p-003 p-004 p-005	No. 9 Turbine - Ground floor/ EF-78	Yellow Red Black	5"	120 120 120	Yes Yes Yes	ME-070 (yellow) 80% Amosite

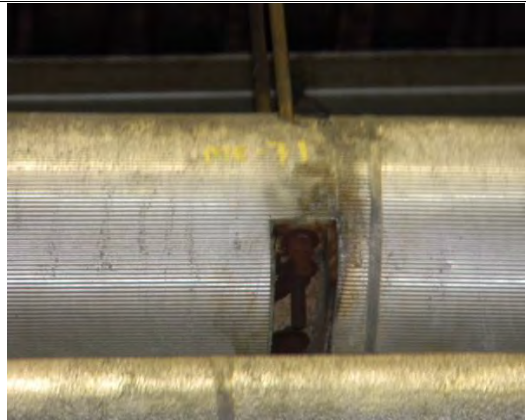
3	p-006	No. 9 Turbine - Turbine Floor/ CD-78	250 LB Aux Steam Line (metal cladding)	15"	175	Yes	ME-071 90% Amosite

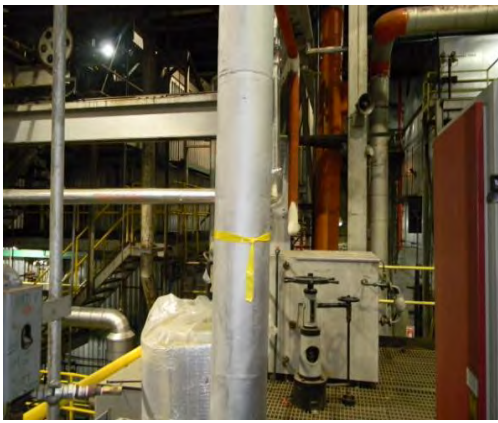
Mechanical Friable Pipe ACM								Site Photo
Photo No.	Pipe ID#	Location / Grid ID	Design ID / colour	Approx. diameter	Approx. Length (l.f)	Re-Insulate (Yes/No)	Asbestos Content	
4	p-007	No. 9 Turbine - Turbine Floor CD-78	Pipe insulation with Metal cladding	10"	15	Yes	Ref: ME-069 80% Amosite

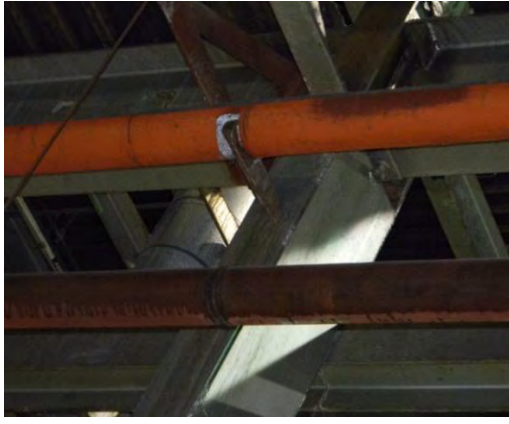
5	p-008	No. 9 Turbine - Turbine Floor CD-78	Pipe insulation/ Orange	6"	165	Yes	Ref: ME-069 80% Amosite

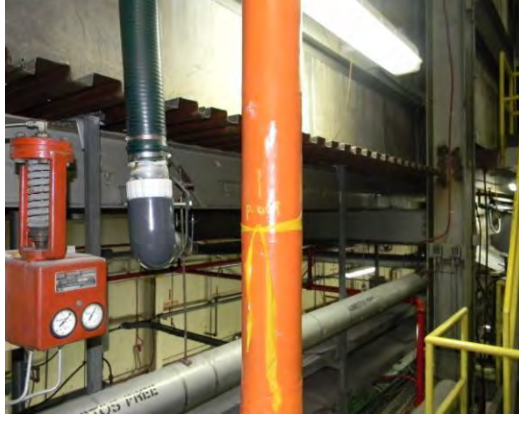
6	p-009	No 9 Boiler (east side) 1st grate Level/ AG-78	Pipe insulation/ Orange	5"	100	Yes	Ref: ME-069 80% Amosite

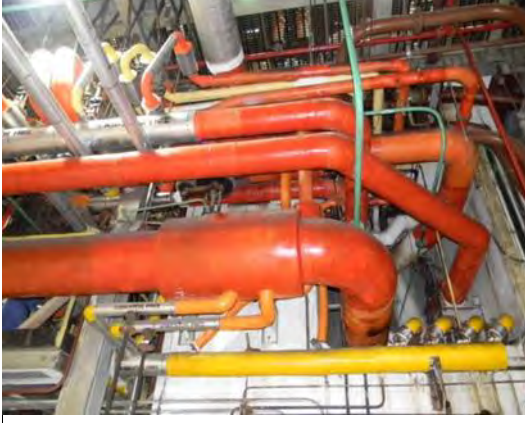
7	p-013 - 024	No. 9 Turbine Ground level DE-78	Pipe insulations orange / yellow	various sizes	--	Yes	*Approx. 50% complete.

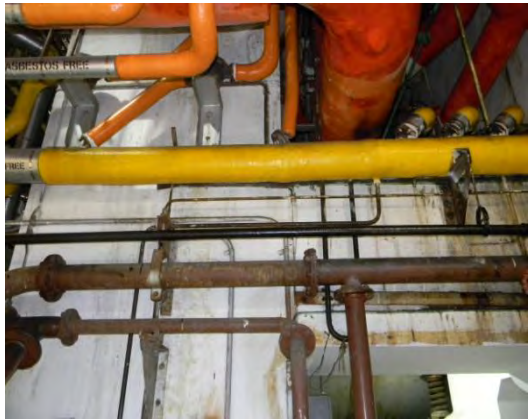
Mechanical Friable Pipe ACM								Site Photo
Photo No.	Pipe ID#	Location / Grid ID	Design ID / colour	Approx. diameter	Approx. Length (l.f)	Re-Insulate (Yes/No)	Asbestos Content	
8	p-013	No. 9 Turbine Ground level DE-78	Pipe insulation to DFC flashbox/ yellow	12"	12	Yes	Ref: ME-070 (yellow) 80% Amosite

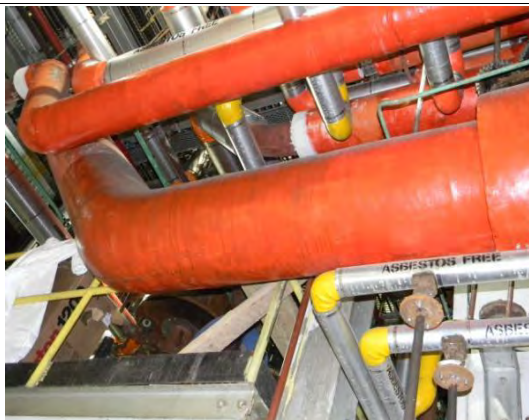
9	p-014	No. 9 Turbine Ground level DE-78	Pipe insulation/ orange	20"	75	Yes	Ref: ME-069 80% Amosite

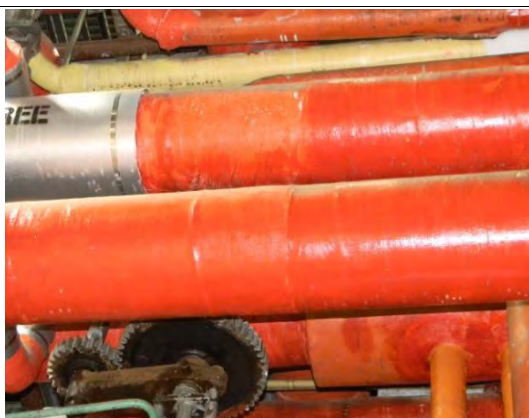
10	p-015 p-016	No. 9 Turbine Ground level DE-78	Pipe insulation/ orange	10"	50 35	Yes Yes	Ref: ME-069 80% Amosite

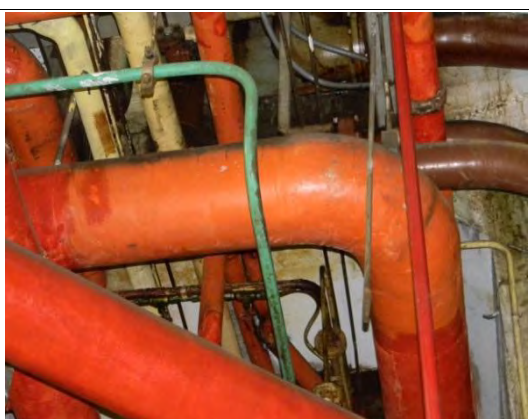
11	p-017	No. 9 Turbine Ground level DE-78	Pipe insulation/ orange	12"	35	Yes	Ref: ME-069 80% Amosite

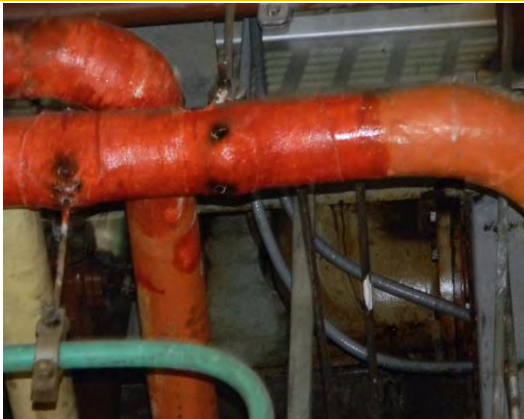
Mechanical Friable Pipe ACM								Site Photo
Photo No.	Pipe ID#	Location / Grid ID	Design ID / colour	Approx. diameter	Approx. Length (l.f)	Re-Insulate (Yes/No)	Asbestos Content	
12	p-018	No. 9 Turbine Ground level DE-78	Pipe insulation/ orange	6"	35	Yes	Ref: ME-069 80% Amosite

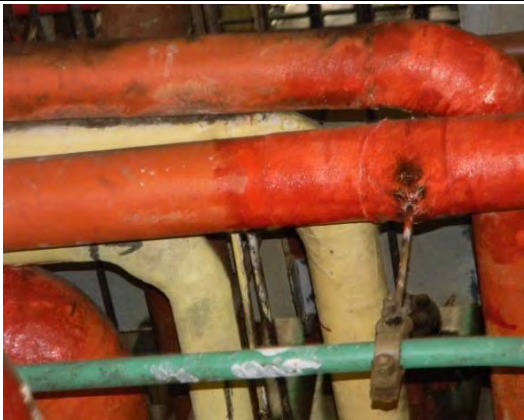
13	p-019 p-020 p-021	No. 9 Turbine Ground level DE-78	yellow yellow orange	5"	30 30 30	Yes Yes Yes	Ref: ME-070 (yellow) 80% Amosite

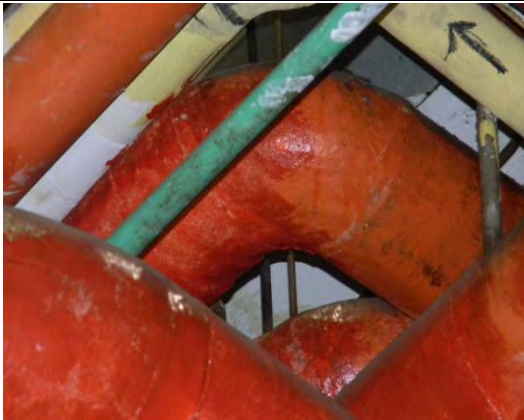
14	p-022	No. 9 Turbine Ground level DE-78	Pipe insulation/ orange	10"	20	Yes	Ref: ME-069 80% Amosite

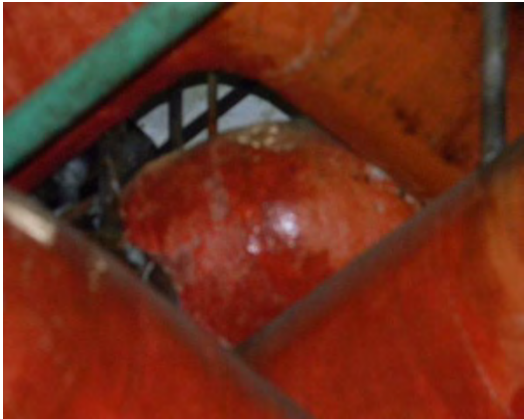
15	p-023	No. 9 Turbine Ground level DE-78	Pipe insulation/ orange	10"	15	Yes	Ref: ME-069 80% Amosite

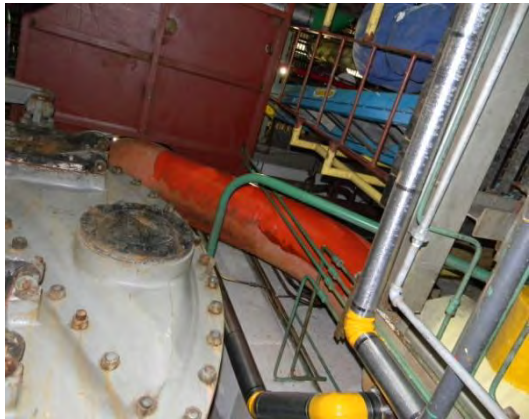
Mechanical Friable Pipe ACM								Site Photo
Photo No.	Pipe ID#	Location / Grid ID	Design ID / colour	Approx. diameter	Approx. Length (l.f)	Re-Insulate (Yes/No)	Asbestos Content	
16	p-024	No. 9 Turbine Ground level DE-78	Pipe insulation from DFC flashbox/ orange	20"	30	Yes	Ref: ME-069 80% Amosite

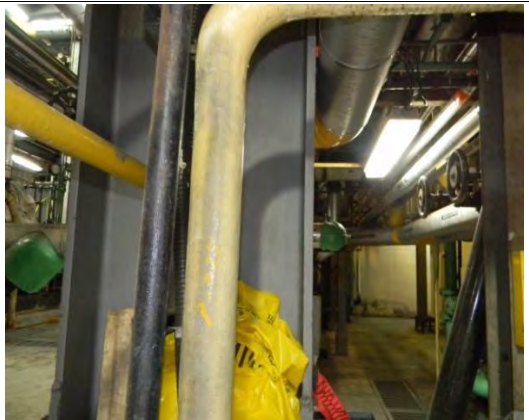
17	p-025	No. 9 Turbine Ground level DE-78	Pipe insulation/ yellow	5"	8	Yes	Ref: ME-070 (yellow) 80% Amosite

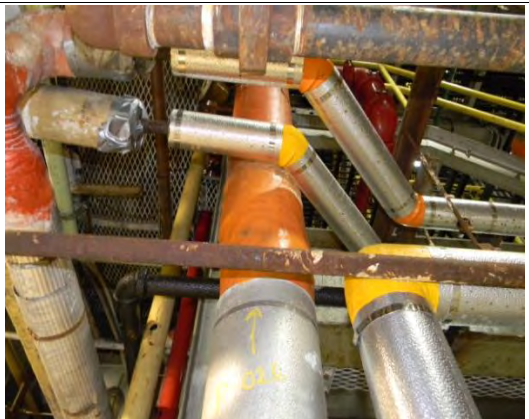
18	p-026	No. 9 Turbine/ CD-89	Pipe insulation/ orange	10"	50	Yes	Ref: ME-069 80% Amosite

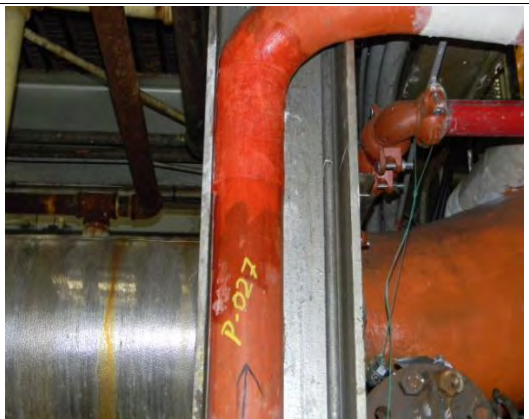
19	p-027	No. 9 Turbine Ground floor/ CD-89	Pipe insulation/ orange	5"	30	Yes	Ref: ME-069 80% Amosite

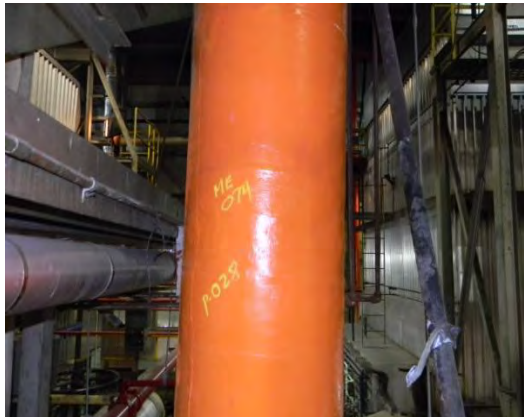
Mechanical Friable Pipe ACM								Site Photo
Photo No.	Pipe ID#	Location / Grid ID	Design ID / colour	Approx. diameter	Approx. Length (l.f)	Re-Insulate (Yes/No)	Asbestos Content	
20	p-028	No. 9 Boiler Turbine level/ BC-78	Pipe insulation/ orange	16"	25	Yes	ME-74 90% Amosite

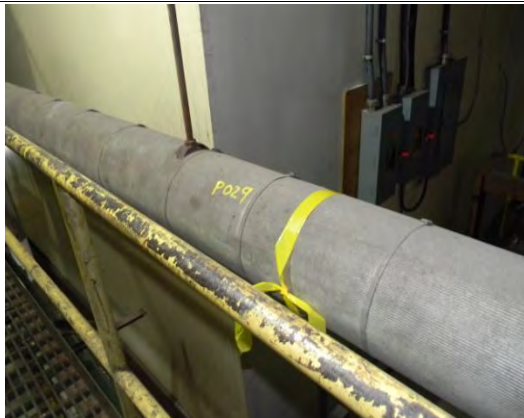
21	p-029	No. 5 Boiler Top Platform AB-56	Pipe insulation with Metal cladding	10"	160	Yes	Ref: ME-069 80% Amosite

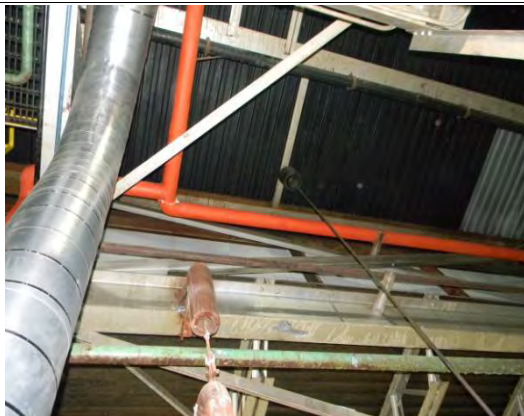
22	Ref: same as p-008	No. 5 Boiler Top Platform BC-56 No access	Pipe insulation/ Orange	6"	included with total estimate previously indicated for P-008	No	Ref: ME-069 80% Amosite

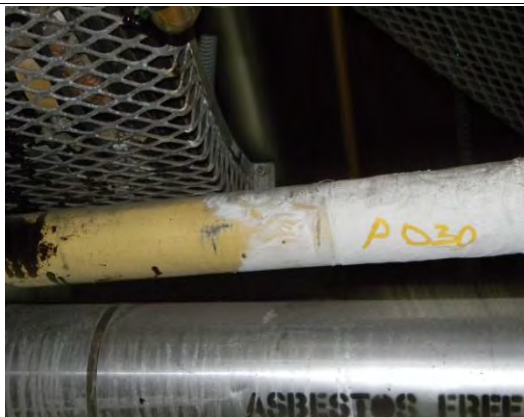
23	p-030	No. 9 Boiler Ground level AG-78	Pipe insulation/ yellow	5"	20	Yes	Ref: ME-070 (yellow) 80% Amosite

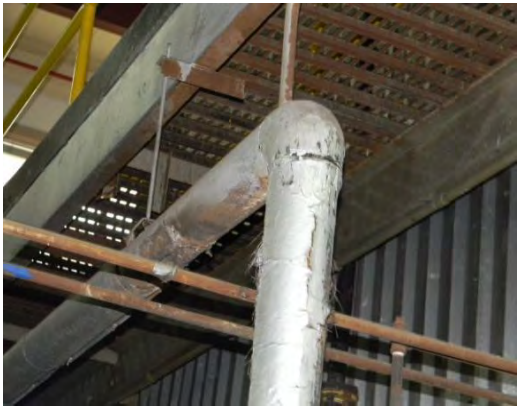
Mechanical Friable Pipe ACM								Site Photo
Photo No.	Pipe ID#	Location / Grid ID	Design ID / colour	Approx. diameter	Approx. Length (l.f)	Re-Insulate (Yes/No)	Asbestos Content	
27	p-037	No. 5 Boiler (north face) 1st elevation/ BC-56	Pipe insulation fibreglass with 1 ACM fitting	6"	1 elbow	No	Presumed ACM

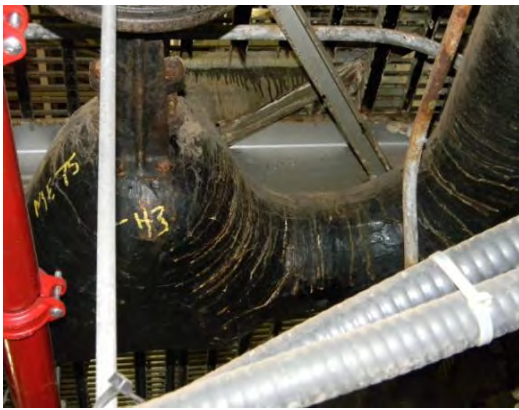
28	p-043	No. 8 Turbine Ground level/ CD-56	mech. Pipe insulation/ valve / black	10"	2 fittings	No	ME-075 25% Chrysotile

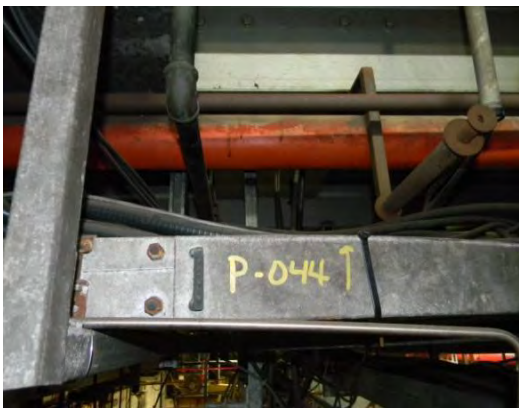
29	p-044	No. 8 screen well area Ground level/ EF-45	Pipe insulation/ Orange	6"	50	No	Ref: ME-069 80% Amosite

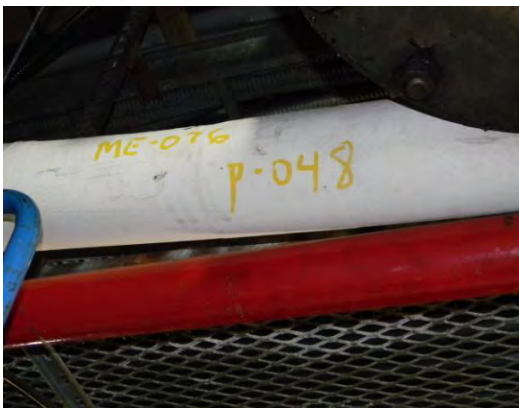
30	p-048	No. 7 Turbine Ground level/ DE-23	pipe insulation/ white	5"	15	No	ME-076 80% Amosite

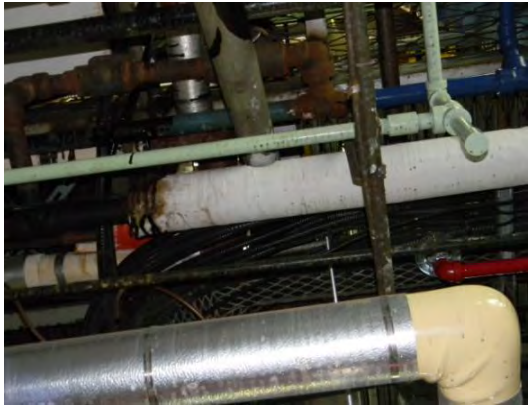
Mechanical Friable Pipe ACM								Site Photo
Photo No.	Pipe ID#	Location / Grid ID	Design ID / colour	Approx. diameter	Approx. Length (l.f)	Re-Insulate (Yes/No)	Asbestos Content	
31	p-049	No. 4 Boiler Ground Level/ AG-34	pipe insulation/ white	6"	25	No	ME-076 80% Amosite

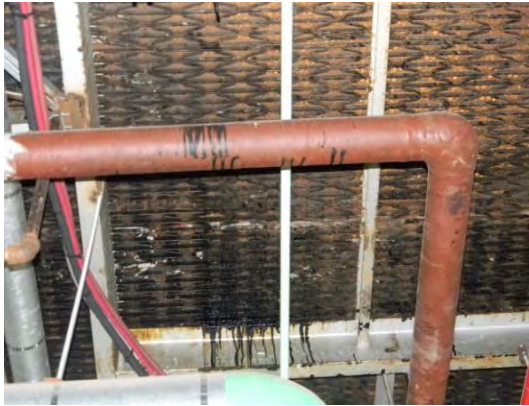
32	p-050	No. 4 Boiler Ground Level/ AG-34	pipe insulation/ brown	6"	50	No	ME-076 80% Amosite

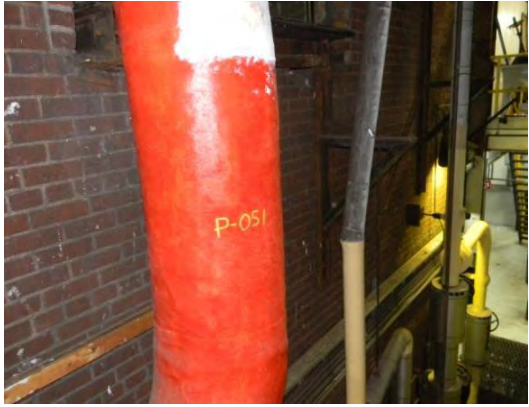
33	p-051	No. 4 Boiler (north) 2nd Platform from top/ AB-23	Orange	18"	35	No	Ref: ME-069 80% Amosite

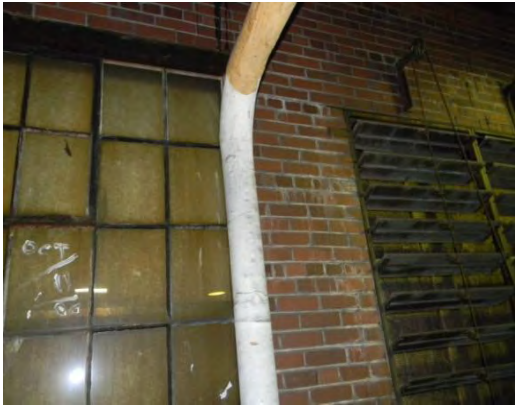
Mechanical Friable Pipe ACM								Site Photo
Photo No.	Pipe ID#	Location / Grid ID	Design ID / colour	Approx. diameter	Approx. Length (l.f)	Re-Insulate (Yes/No)	Asbestos Content	
34	p-052	No. 4 Boiler (top level) / AB-23	Pipe insulation/ yellow	5"	60	No	Ref: ME-070 (yellow) 80% Amosite

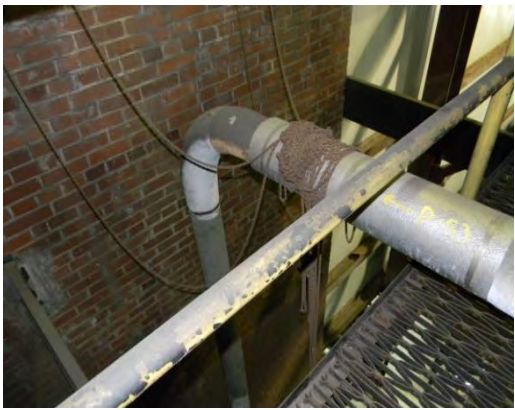
35	p-053	No. 4 Boiler (top level to bottom level)/ AB-23	Pipe insulation/ yellow	5"	40	No	Ref: ME-070 (yellow) 80% Amosite

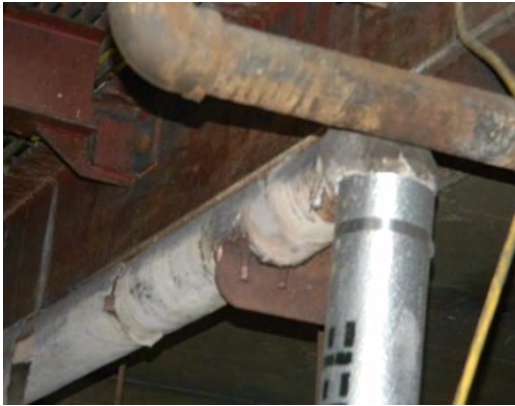
36	p-054	No. 5 Boiler area (viewed from Turbine level)/ BC-67	pipe insulation with metal cladding	14"	30	No	Ref: ME-069 80% Amosite	
37	p-055	Boiler No. 6 (south end) 2nd level grate/ BC-1112	pipe fitting (restricted access) - presumed ACM	4"	10' 1 fitting	No	Ref: ME-076 80% Amosite

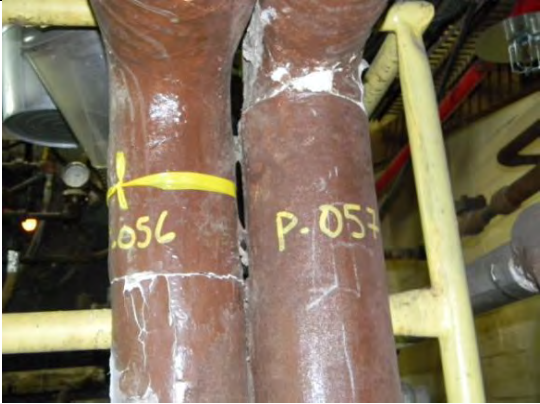
Mechanical Friable Pipe ACM								Site Photo
Photo No.	Pipe ID#	Location / Grid ID	Design ID / colour	Approx. diameter	Approx. Length (l.f)	Re-Insulate (Yes/No)	Asbestos Content	
38	p-056 p-057	Ground level/ CD-1314	pipe insulation/ brown	6"	15 15	No No	ME-076 80% Amosite

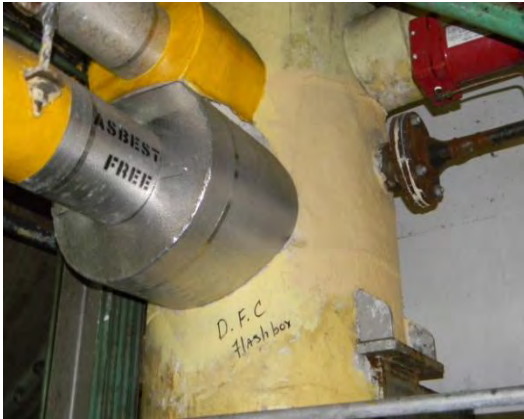
Mechanical Friable ACM							Site Photo
Photo No.	Mech. ID#	Location / Grid ID	Design ID	Approx. Dimensions	Re-Insulate (Yes/No)	Asbestos Content	
1	m-001	No. 9 Turbine (east side) Ground level/ CD-89	Mech. Insulation on DFC flashbox/ Yellow	Dia. - 24" Length - 60"	Yes	Ref: ME-070 (yellow) 80% Amosite

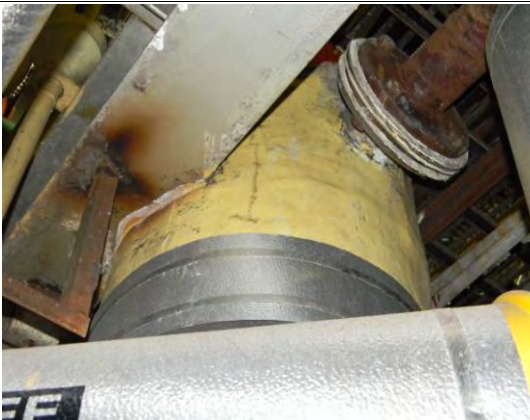
2	m-002	No. 9 Turbine (east side) Ground level/ CD-89	Mech. Insulation on DFC flashbox 2/ Yellow	Dia. - 18" Length - 24"	Yes	Ref: ME-070 (yellow) 80% Amosite

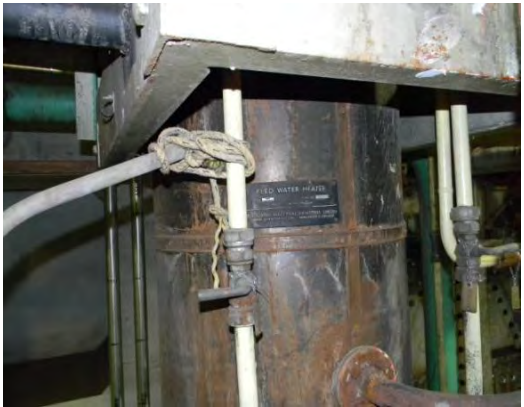
3	m-003	No. 9 Turbine - Turbine level/ CD-89	Mech. Insulation on Feed water heater under metal casing		Yes	ME-028 55% Chrysotile

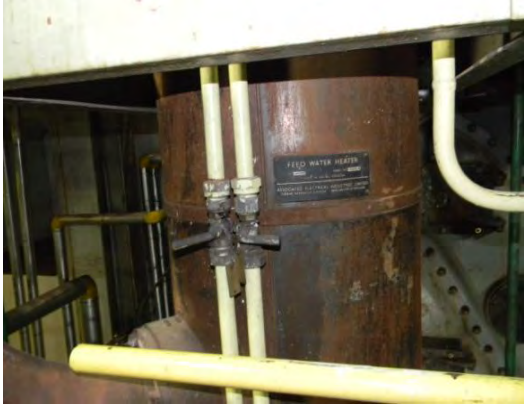
Mechanical Friable ACM							Site Photo
Photo No.	Mech. ID#	Location / Grid ID	Design ID	Approx. dimensions	Re-Insulate (Yes/No)	Asbestos Content	
4	m-004	No. 9 Turbine - Turbine level/ CD-89	Mech. Insulation on Feed water heater No. 2 under metal casing		Yes	Ref: ME-028 55% Chrysotile

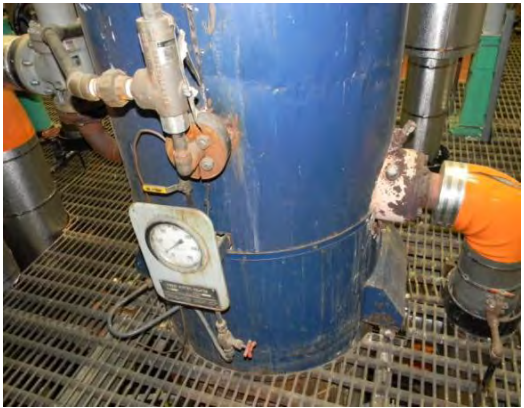
5	m-005	No. 9 Turbine - Turbine level/ CD-89	Mech. Insulation on Feed water heater No. 1 under metal casing	Diameter - 32" Length - 138"	Yes	Ref: ME-028 55% Chrysotile

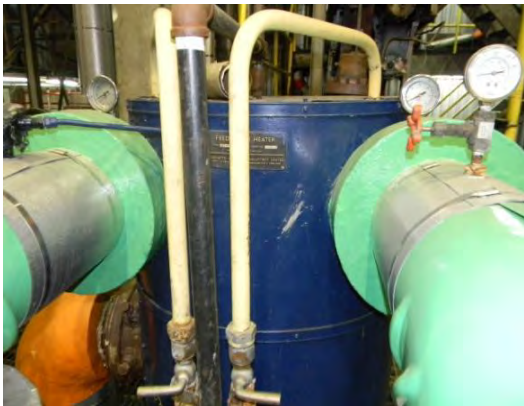
6	m-006	No. 9 Turbine - Turbine level/ CD-89	Mech. Insulation on Feed water heater No. 2 under metal casing	Diameter - 32" Length - 138"	Yes	Ref: ME-028 55% Chrysotile

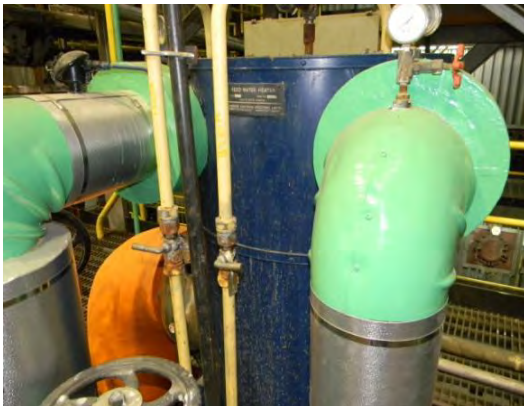
7	m-007	No. 9 Turbine - Turbine level/ CD-89	Mech. Insulation on Feed water heater No. 3 under metal casing	Diameter - 32" Length - 138"	Yes	Ref: ME-028 55% Chrysotile

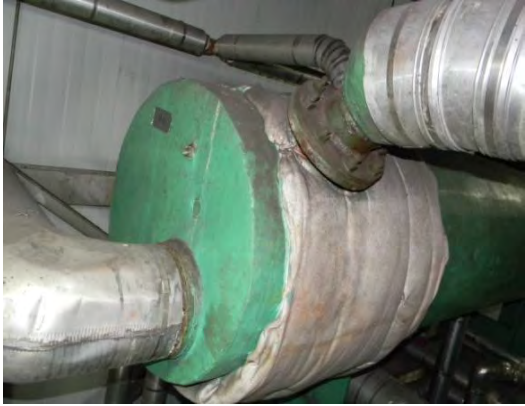
Mechanical Friable ACM							Site Photo
Photo No.	Mech. ID#	Location / Grid ID	Design ID	Approx. dimensions	Re-Insulate (Yes/No)	Asbestos Content	
8	m-008	No. 9 VGNT Condenser Tank - Deaerator level	Mech. Insulation on VGNT condenser tank	Diameter - 30" Length - 144"	Yes	ME-023 45% Chrysotile

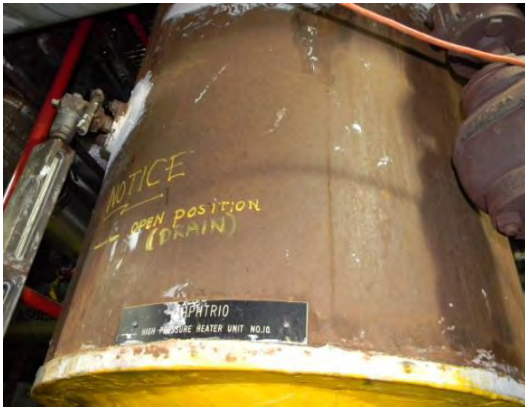
9	m-009	No. 10 High Pressure Heater Unit 1st grate level/ KL-910	Mech. Insulation on High pressure heater unit under metal casing	Diameter - 40" Length - 138"	Yes	ME-010 45% Amosite 25% Chrysotile

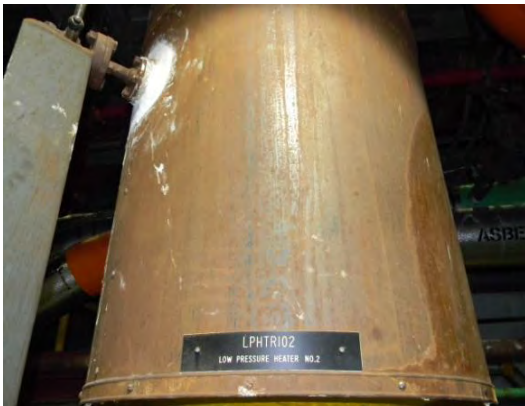
10	m-010	No. 10 Low Pressure Heater Unit No. 2 1st grate level/ KL-89	Mech. Insulation on Low pressure heater unit No. 1 under metal casing	Diameter - 40" Length - 138"	Yes	Ref: ME-010 45% Amosite 25% Chrysotile

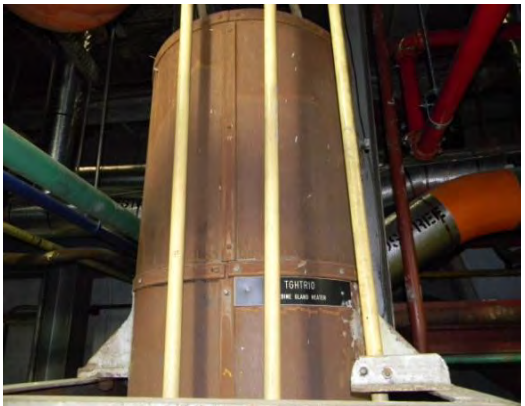
11	m-011	No. 10 Turbine Gland heater 1st grate level/ KL-89	Mech. Insulation on Gland heater unit under metal casing	Diameter - 24" Length - 78"	Yes	ME-010 45% Amosite 25% Chrysotile

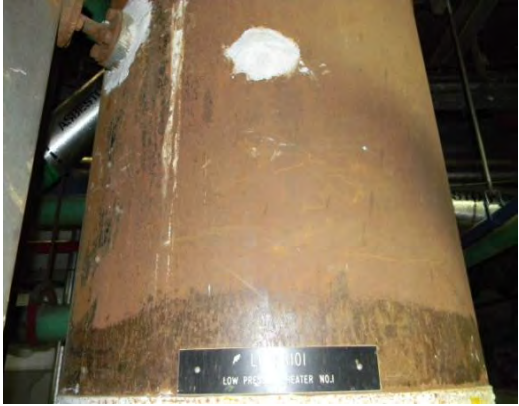
Mechanical Friable ACM							Site Photo
Photo No.	Mech. ID#	Location / Grid ID	Design ID	Approx. dimensions	Re-Insulate (Yes/No)	Asbestos Content	
12	m-012	No. 10 Low pressure heater No. 1 1st grate level/ KL-89	Mech. Insulation on Low pressure heater unit No. 1 under metal casing	Diameter - 40" Length - 138"	Yes	Ref: ME-010 45% Amosite 25% Chrysotile

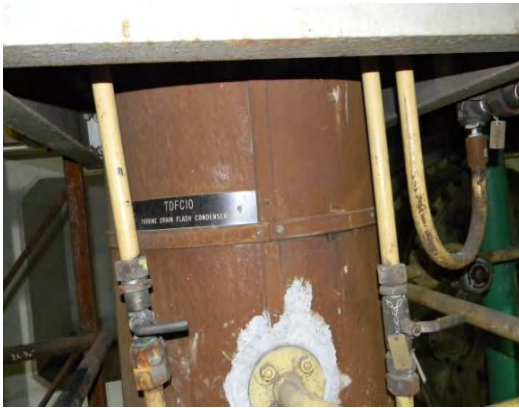
13	m-013	No. 10 Turbine drain flash condenser 1st grate level/ KL-89	Mech. Insulation on Drain Flash Condenser under metal casing	Diameter - 24" Length - 78"	Yes	Ref: ME-010 45% Amosite 25% Chrysotile

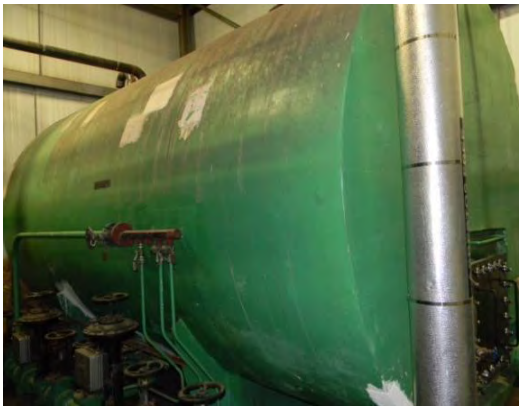
14	m-014	No. 10 High Level Tank Deaerator level	Mech. Insulation on High level tank	Diameter - 111" Length - 189"	Yes	ME-001 60% Chrysotile

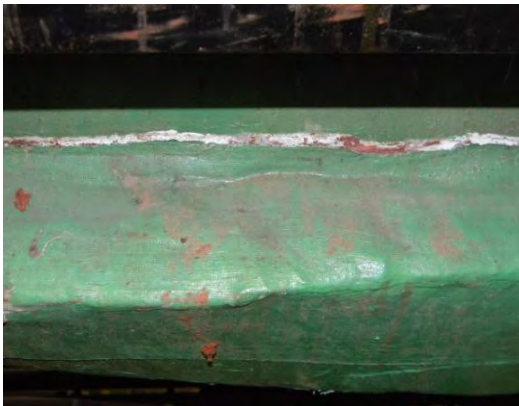
15	m-015	No. 10 High Level Tank Deaerator level	High level tank	Thickness - 3" Same as M-014, extra note to clarify thickness	Yes	ME-001 60% Chrysotile

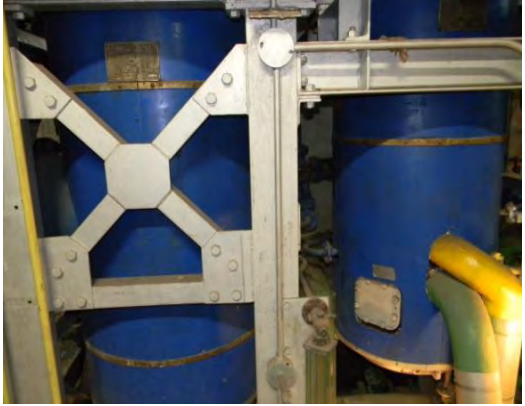
Mechanical Friable ACM							Site Photo
Photo No.	Mech. ID#	Location / Grid ID	Design ID	Approx. dimensions	Re-Insulate (Yes/No)	Asbestos Content	
20	m-020	No. 6 Turbine Feed Water Heaters Ground level/ CD-1112	Mech. Insulation on feed water heaters under metal casing	Each tank Diameter - 28" Length 72"	No	Ref: ME-028 55% Chrysotile

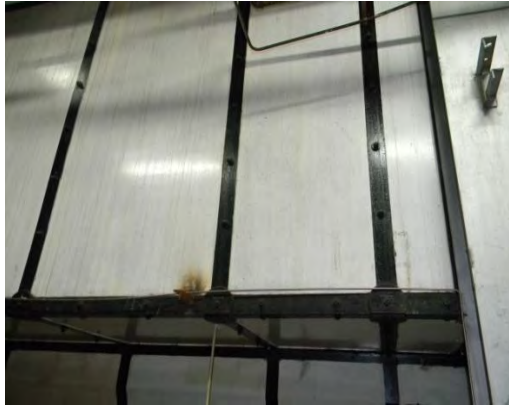
21	m-021	No. 4 Boiler	Mechanical insulation within boiler walls		No	Ref: ME-005 25% Amosite

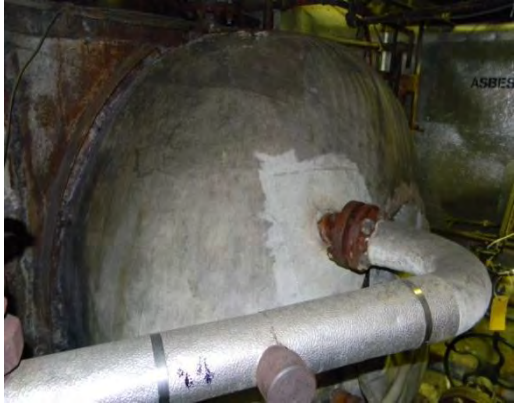
22	m-022	No. 4 Boiler (top level)	Mech. Insulation steam drum		No	Ref: ME-005 25% Amosite

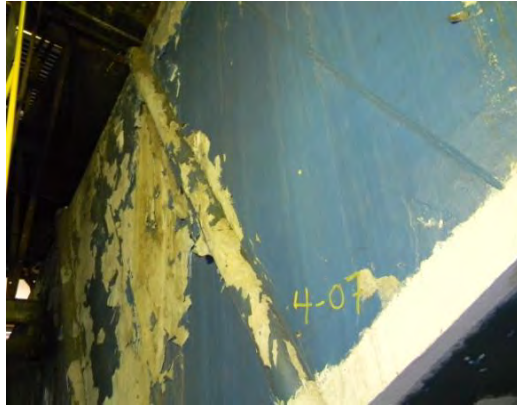
23	m-023	No. 4 Boiler (east side)	Mech. Insulation stack (blue)		No	ME-047 60% Chrysotile

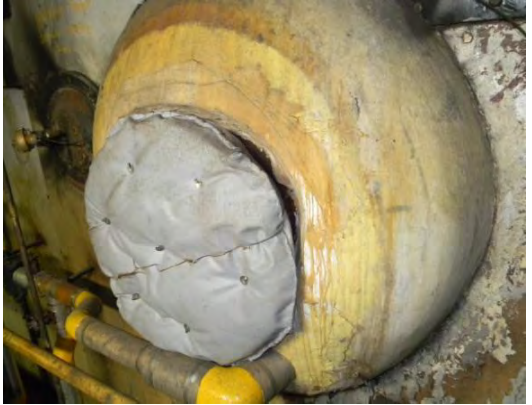
Mechanical Friable ACM							Site Photo
Photo No.	Mech. ID#	Location / Grid ID	Design ID	Approx. dimensions	Re-Insulate (Yes/No)	Asbestos Content	
24	m-024	No. 4 Boiler (north side) Turbine level/ AB-23	Mech. Insulation steam drum		No	Ref: ME-005 25% Amosite

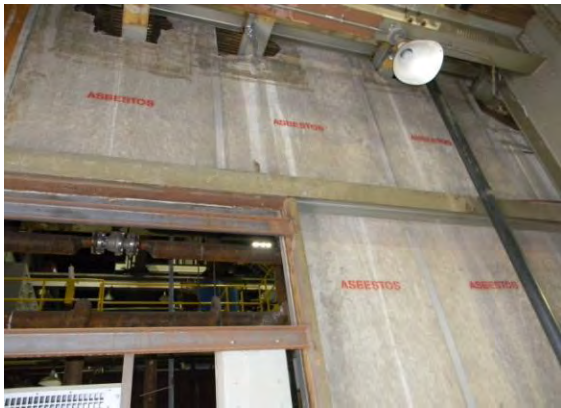
Non friable ACM							Site Photo
Photo No.	Non friable ID#	Location / Grid ID	Design ID	Approx. Area (ft2)	Replace (Yes/No)	Asbestos Content	
4	n-004	No. 9 Turbine (west side) Ground level/ F/7-10	corr. transite panel / wall	660	No	Ref: 033 35% Chrysotile

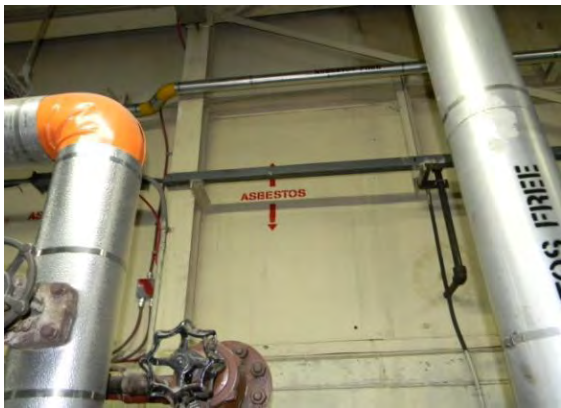
5	n-005	No. 9 Boiler (east wall) adjacent to MGOH room Ground level/ G/7-10	transite panel / wall	900	Yes replace with similar materials as adjacent wall	Ref: 033 35% Chrysotile

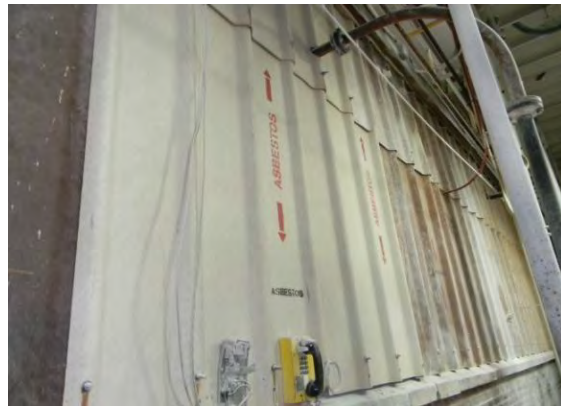
6	n-006	MGOH Room (west side) adjacent to No. 9 Boiler east/ 7-10/G	corr. transite panel / wall	900	No	Ref: 033 35% Chrysotile

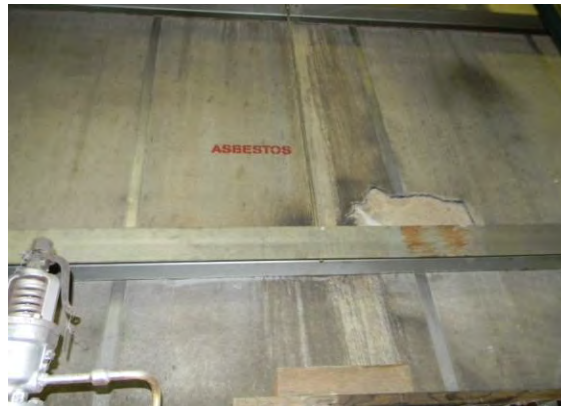
7	n-007	No. 9 Boiler (east wall) Upper level/ A/7-10	transite panel / wall	2000	Yes, replace with same materials as item #5	Ref: 033 35% Chrysotile

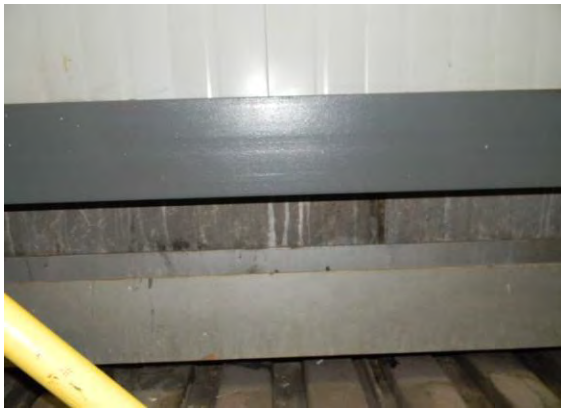
Non friable ACM							Site Photo
Photo No.	Non friable ID#	Location / Grid ID	Design ID	Approx. Area (ft2)	Replace (Yes/No)	Asbestos Content	
8	n-008	No. 10 Boiler Deaerator Tank Level	transite panel / wall	225 (approx. 2 ft. visible surface area)	Yes, replace with similar material as adjacent wall.	Ref: 033 35% Chrysotile

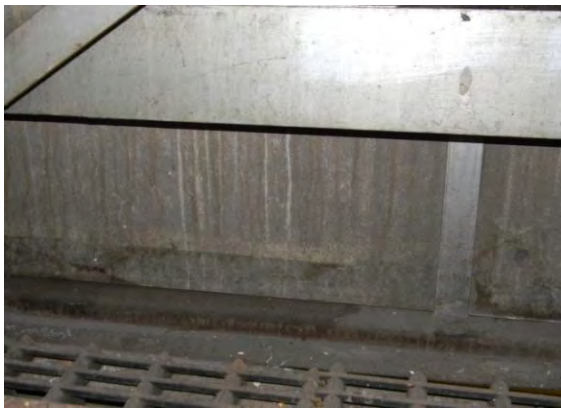
9	n-009	No. 9 Boiler Deaerator Tank Level	transite panel / wall	170 (approx. 2 ft. visible surface area)	Yes, replace with same material as #8	Ref: 033 35% Chrysotile

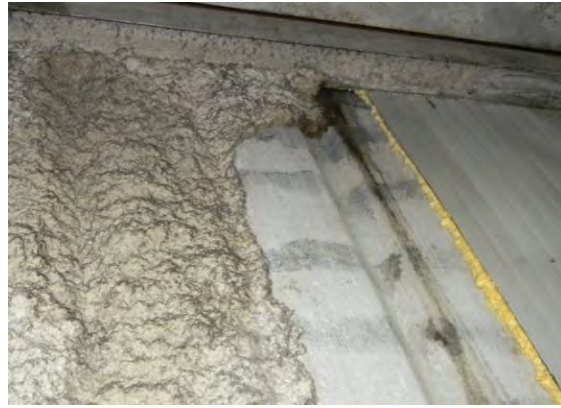
10	n-010	GA Compressor No.4 area Ground level/ AG-12	transite panel / wall	120	Yes, replace with materials to match adjacent plant walls.	Ref: 033 35% Chrysotile

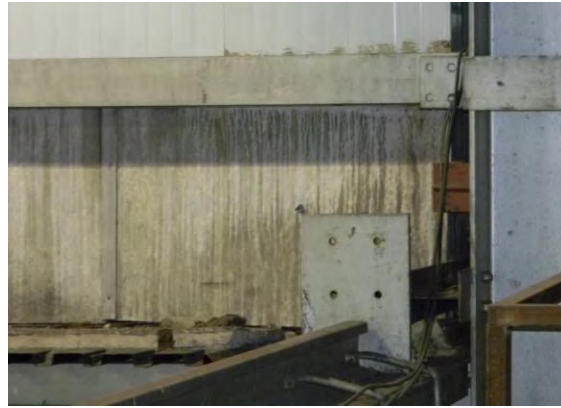
11	n-011	No. 9 Turbine Area (north wall) restricted height access turbine level/ A-F/7	transite panel / wall	150 (approx. 2 ft. visible surface area)	Yes, replace with similar materials as adjacent wall.	Ref: 033 35% Chrysotile
