# **MARITIME ELECTRIC**

# **CHARLOTTETOWN GENERATING STATION**

## **STUDY**

PERFORM AN ANALYSIS ON THE REQUIREMENTS TO OPERATE THE GENERATING UNITS IN A SAFE MANNER TO THE END OF 2018

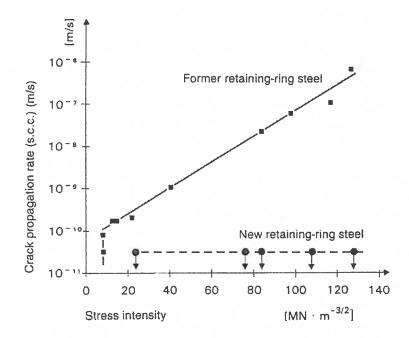
With the old material, the crack propagation rate increases rapidly with stress level, as shown by our tests. In these tests, the lowest measurable crack propagation rate was  $2 \times 10^{-11}$  m/s (measurement accuracy). With the new material, no crack propagation could be detected over the whole stress range. We therefore know it is certainly below  $2 \times 10^{-11}$  m/s, as indicated in the diagram by the arrows pointing downward.

Figure 3: Crack propagation rates old steel / new steel

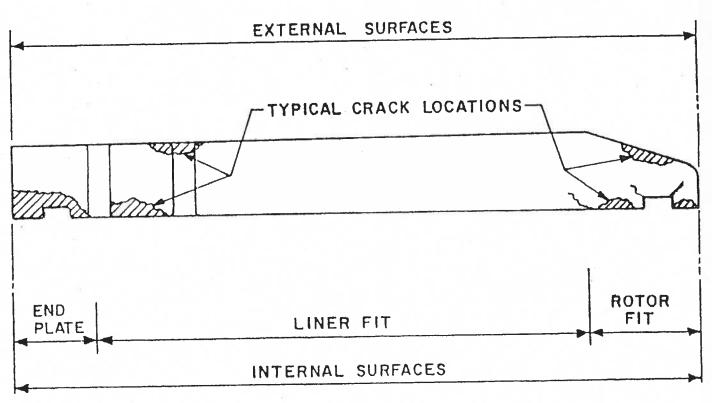
Fig. 2 Location of cracks found during In-Service Inspection of Endrings (Corrosion pitting may be found on all endring surfaces)
