**Record filed by
The City of Charlottetown
In the matter of
Louise Aalders v. City of Charlottetown
(Appeal #LA25011)**

**MARINE BENTHIC SURVEY, FISHERY AND SARA KNOWLEDGE
OF
THE BANKS HAVILAND STREET DEVELOPMENT WATER LOT,
CHARLOTTETOWN HARBOUR,
QUEENS COUNTY, PRINCE EDWARD ISLAND**

PROJECT NO. GR2029

MARCH 15, 2021

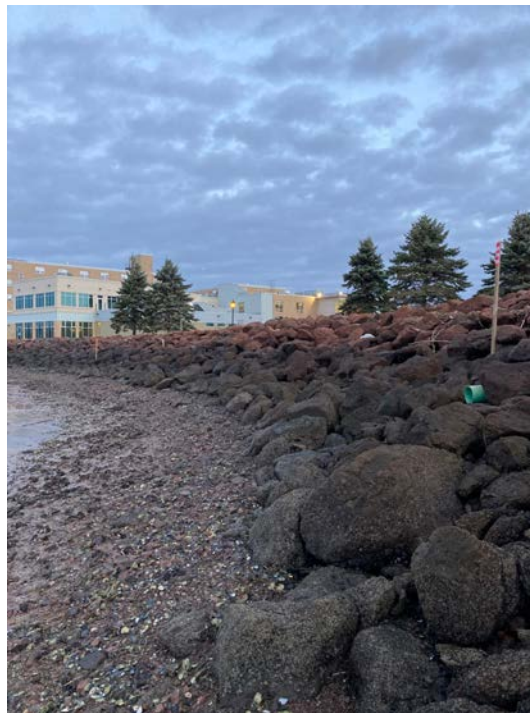
Figure 1. Photo (taken at low tide) of the The Banks Haviland Street Development shore line of the Charlottetown Harbour/Hillsborough Bay facing north west from the southern edge of the property. The wooden stake above the green pipe protruding from the armor stone (right side of photo) is the ranging stake for the end of dive survey transect T1.

The water lot/waterfront is located on a small, shallow embayment that at low tide has extensive sand flats. The upland/water lot interface has a imported stone shoreline armour wall as seen in Figure 1.

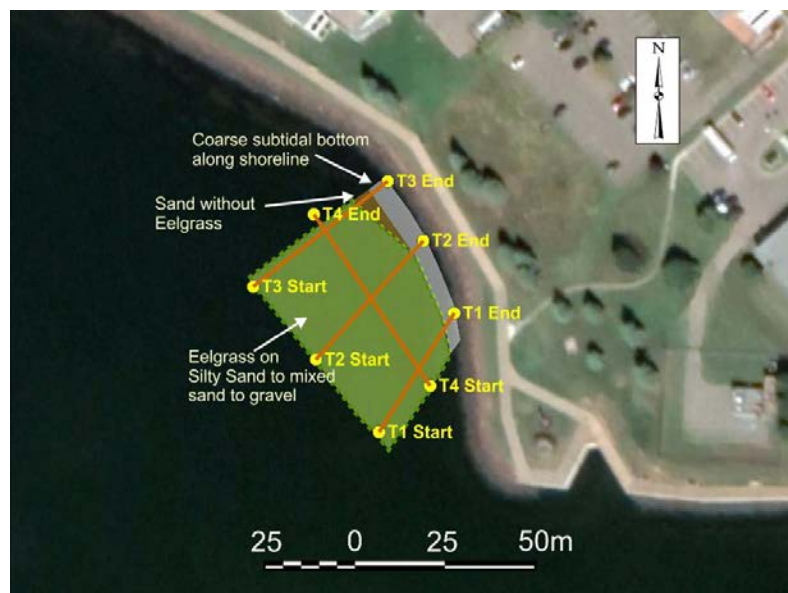
Figure 4. Biological communities and substrate zones, determined from seabed video.

Transect 4 extends southeast to northwest roughly parallel to shore through an eelgrass bed and is approximately 8 m from shore on the southeast to 23 m from shore on the northwest. Eelgrass is the only plant species present, occurring typically at 80-90% cover but abundance can vary from lower to higher. Substrate is typically silty sand occasionally mixed with minor gravel to cobble and occasional shell, and the proportion of coarser material is greatest at the northwest end. Oysters occur occasionally throughout.

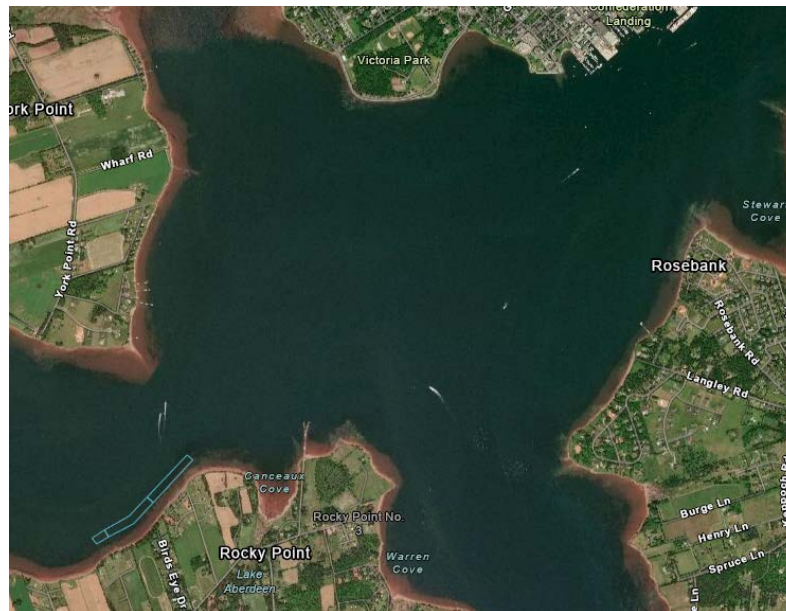
Figure 6. Map of ARCGIS mapping from DFO PEI office for shellfish aquaculture sites for the Charlottetown Harbour area of the Haviland Development water lot. The closest off bottom shellfish lease (blue lines) is approximately 3.2 km south west of the water lot off the Rocky Point area.

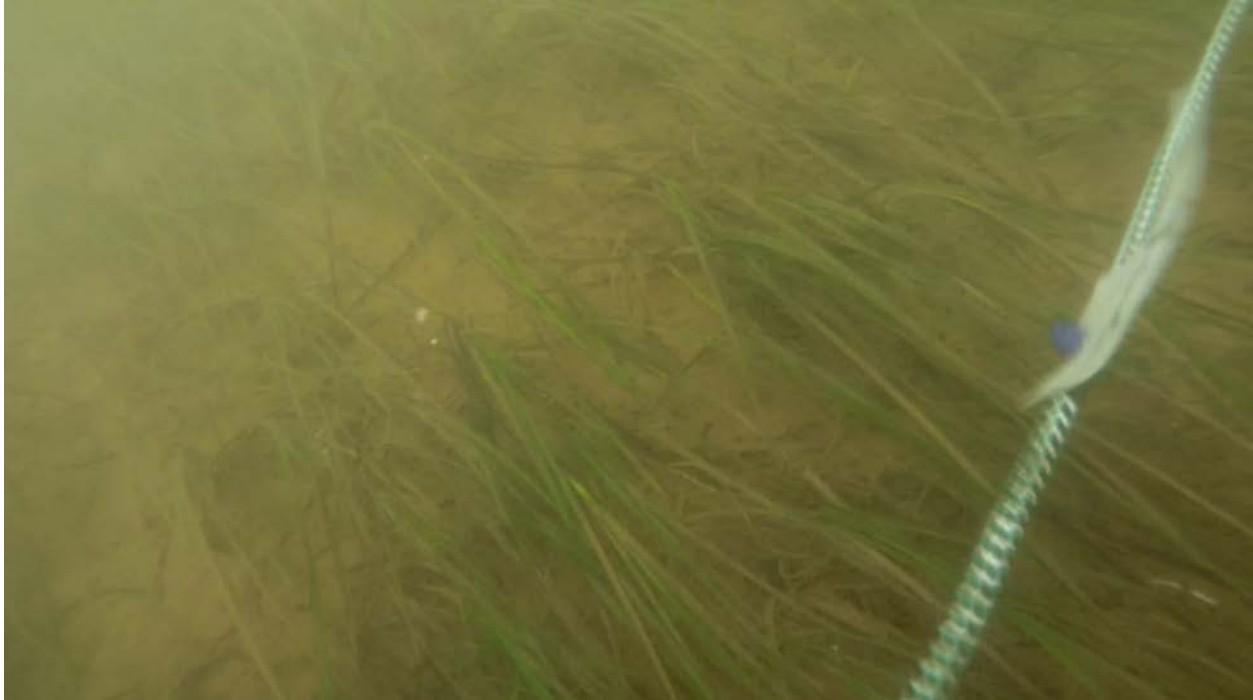
Photo 1. Transect 1, Eelgrass at outer extent of transect (40 m from shore).

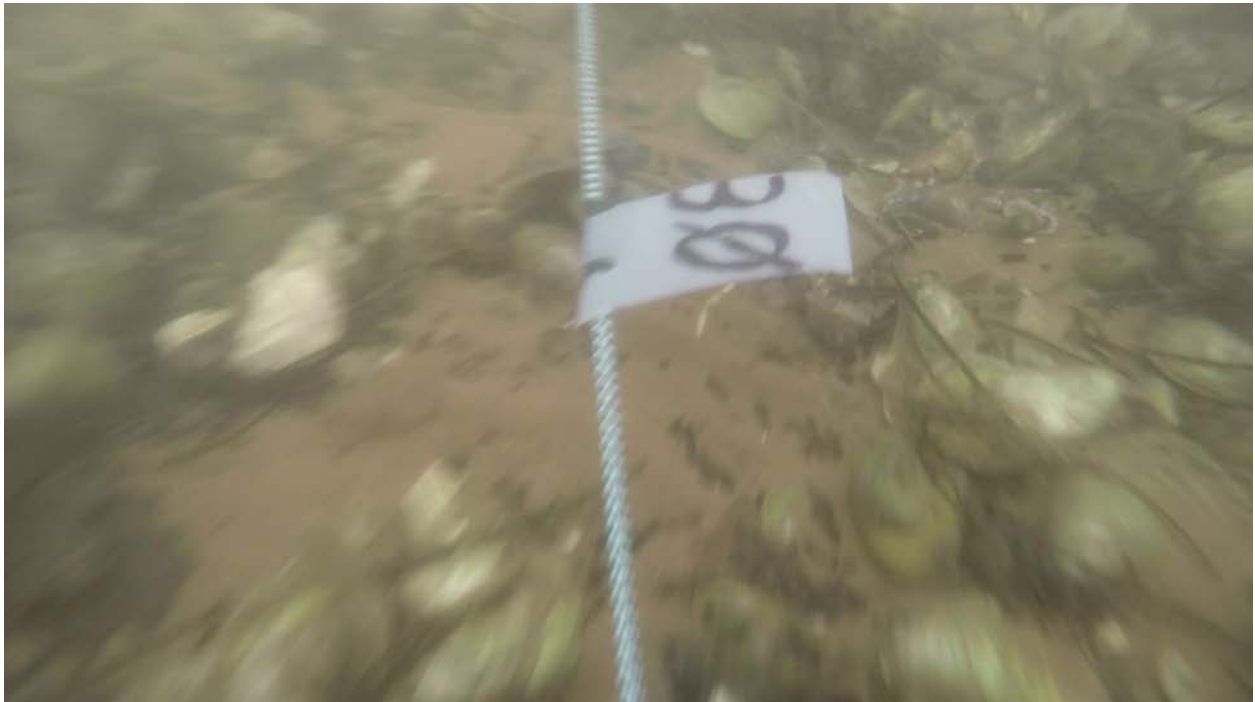
Photo 6. Transect 1, mixed bottom with sand, eelgrass, gravel to cobble and shell, 10 m from shore.

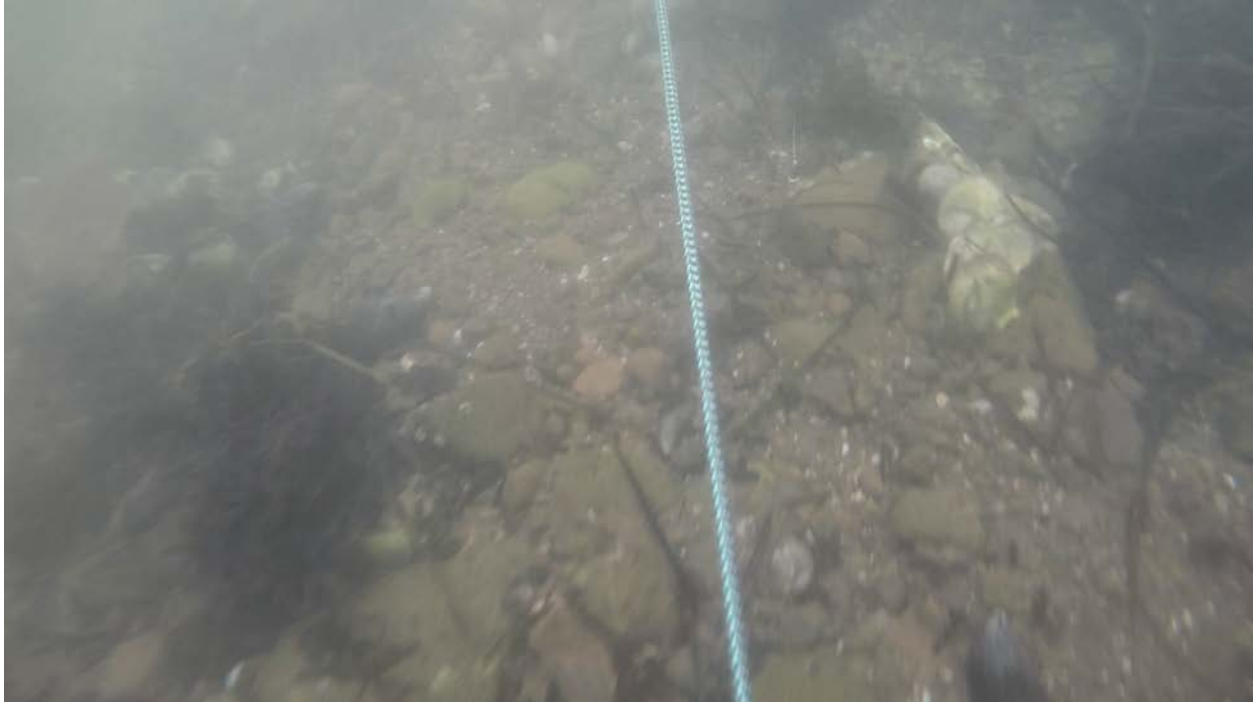
Photo 7. Transect 1, coarse bottom with clumps of rockweed (Fucus sp) and drift Eelgrass, ~ 7 m from armour stone.

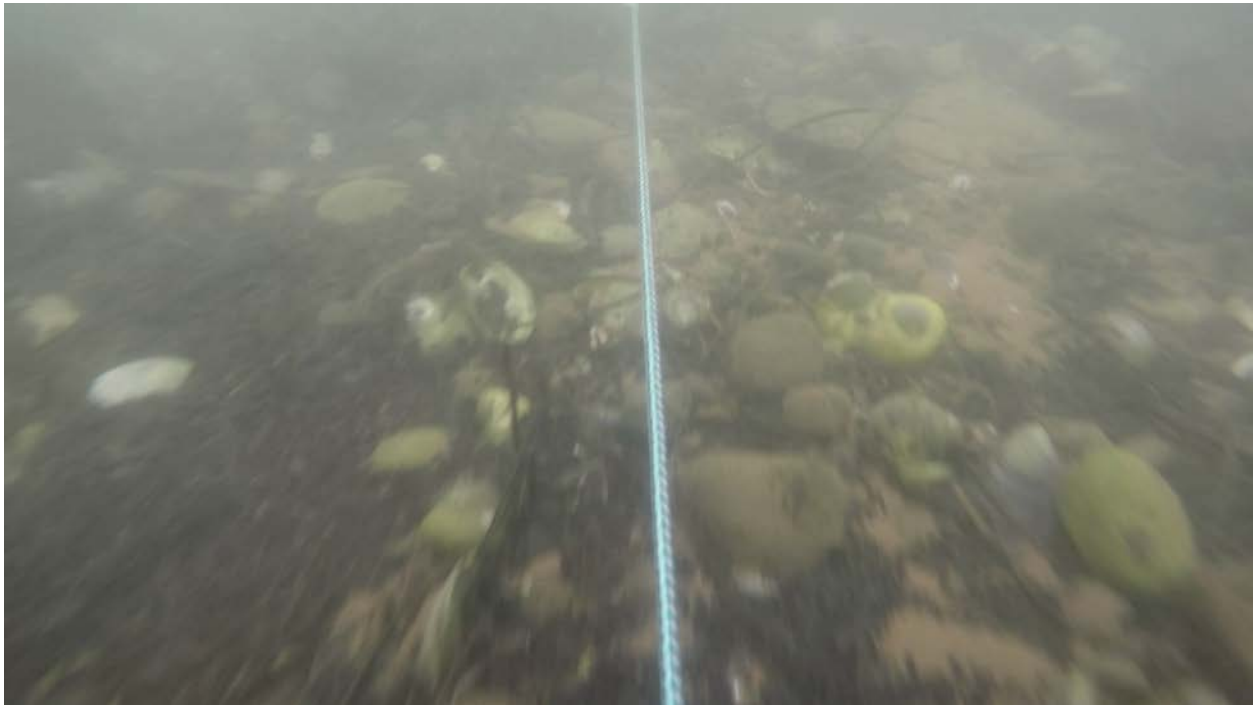
Photo 11. Transect 2, coarse substrate and shells with drift Eelgrass at 7 m from armour stone.

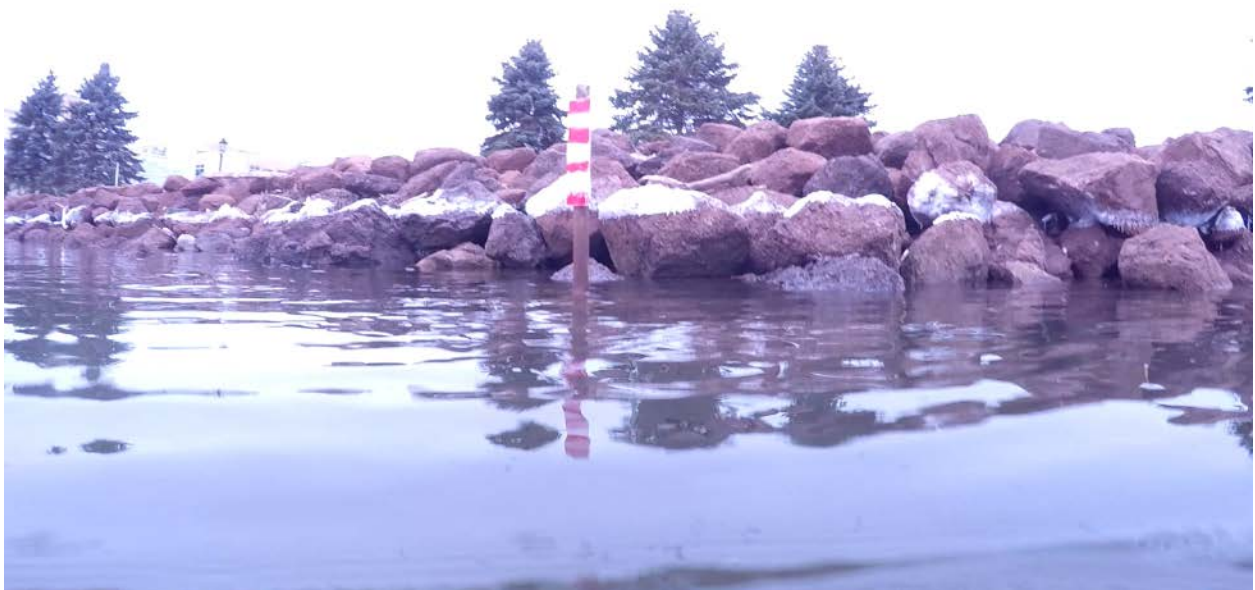
Photo 12. Transect 2, armour stone.

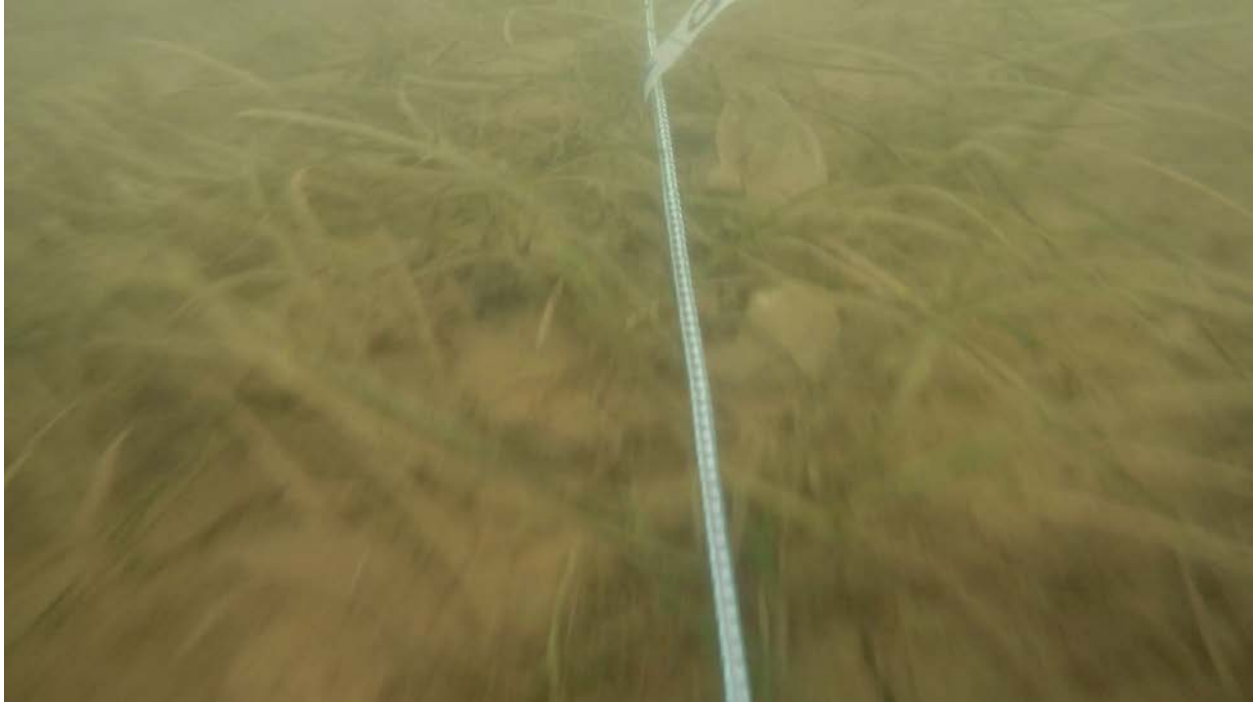
Photo 13. Transect 3, Eelgrass 35 m from shore.

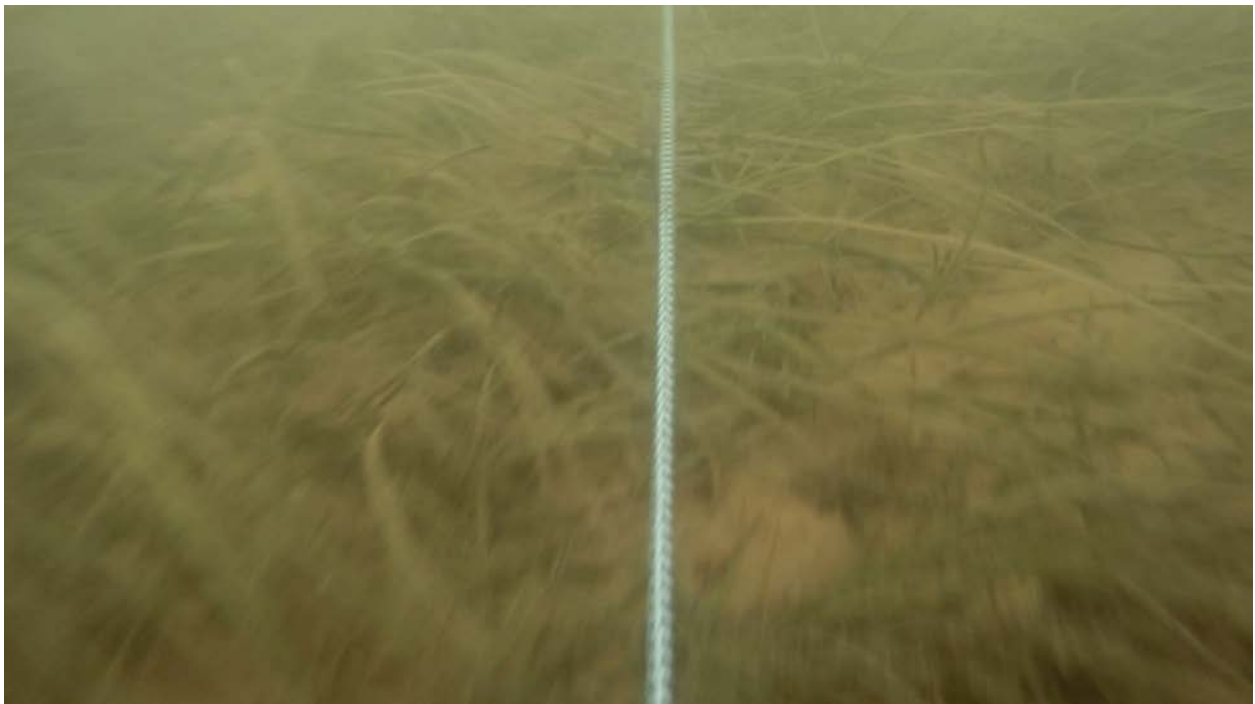
Photo 14. Transect 3, Eelgrass 50 m from shore.

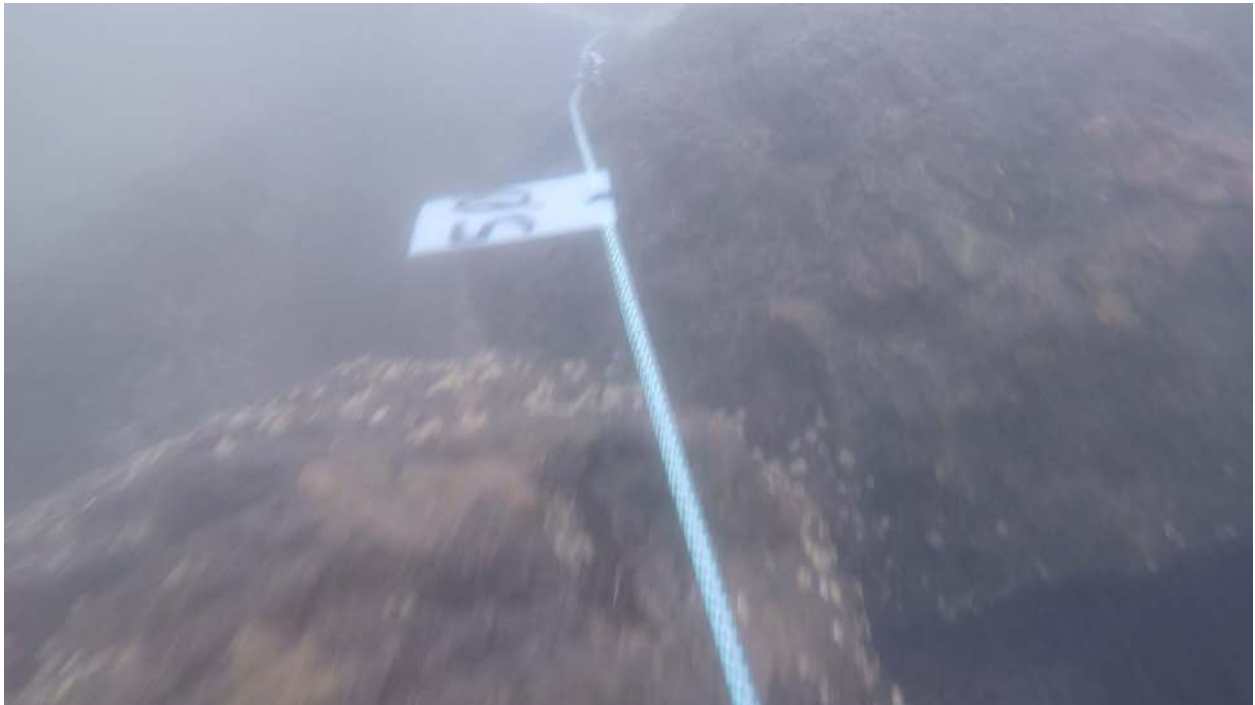
Photo 15. Transect 3, barnacles and encrusting growth on armour stone.

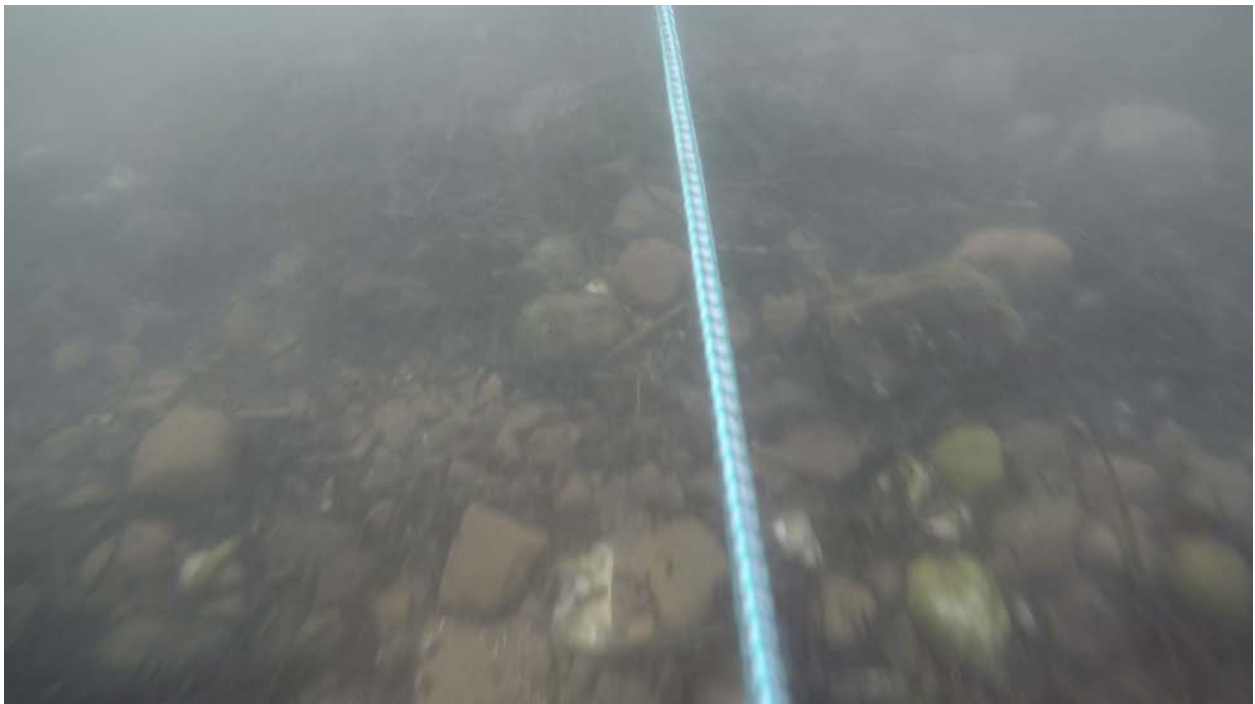
Photo 16. Transect 3, coarse bottom with drift eelgrass at base of armour stone.

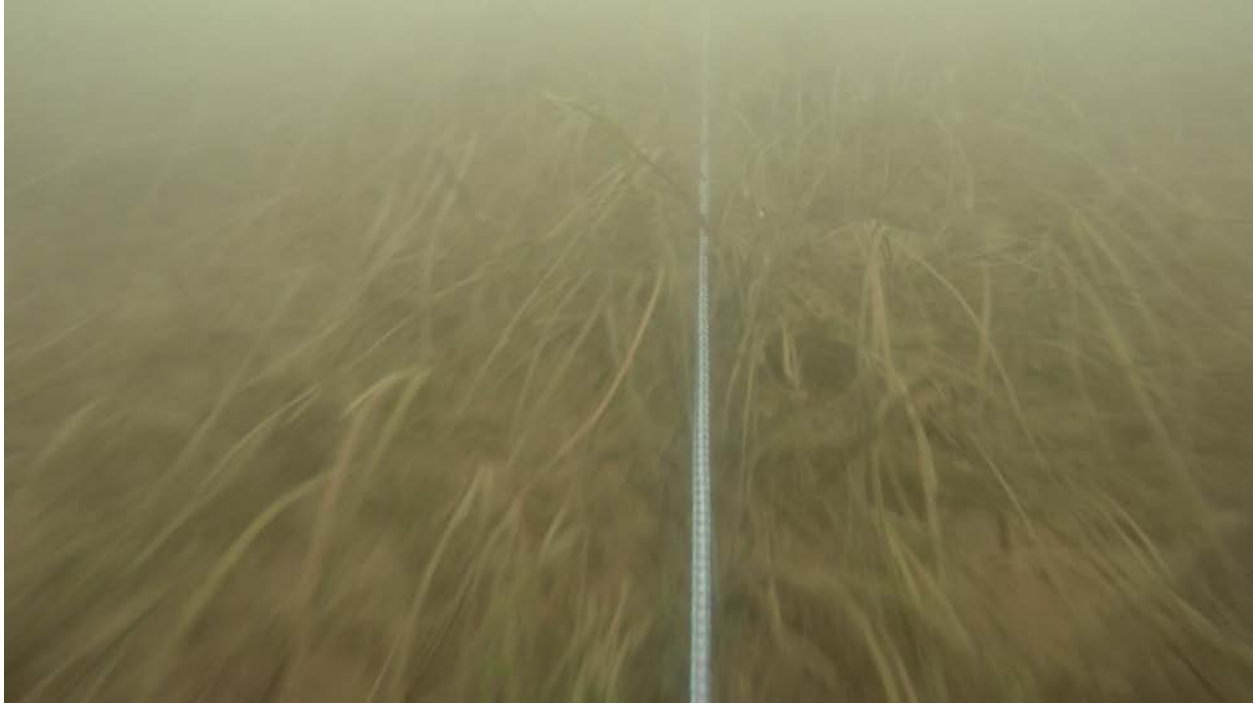
Photo 19. Transect 4, dense Eelgrass bed crossed by transect.

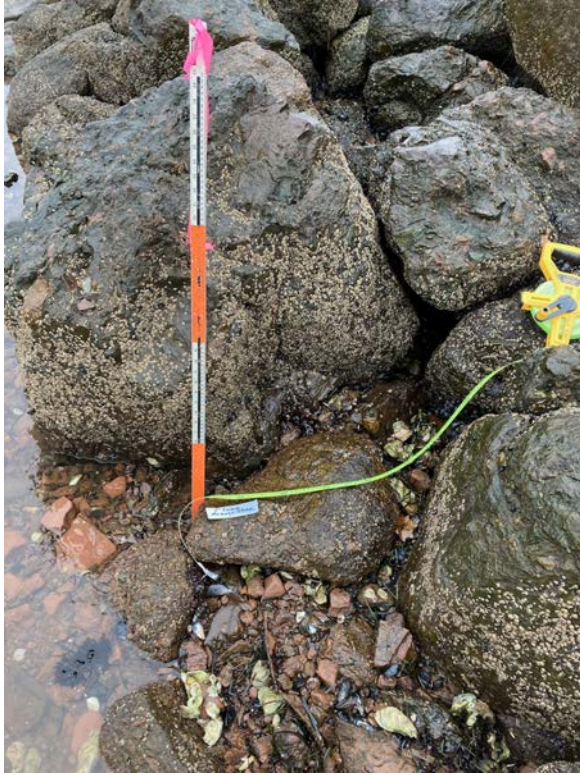
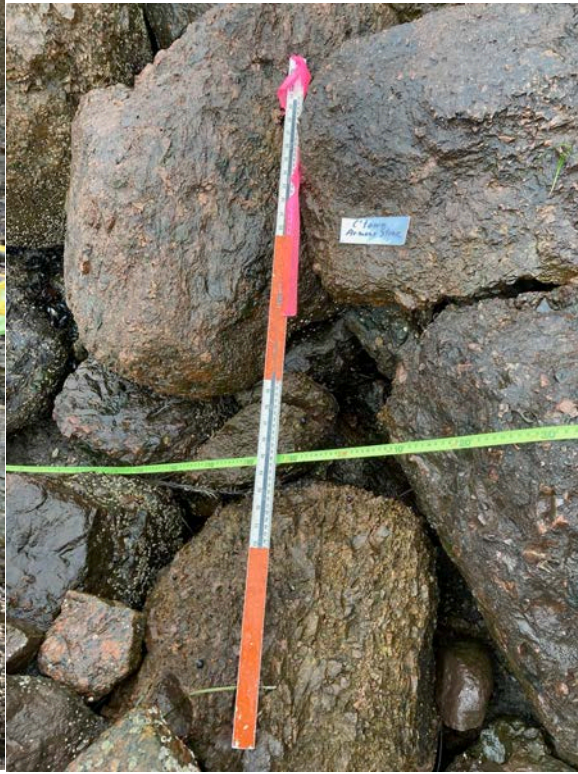
Photo 1. 0m mark on transect, toe of slope Photo 2. 3m mark on transect

The shoreline armor stone supports barnacle communities with a range of approximately 45% coverage at the toe of slope (0m) and a decreasing coverage towards the top of slope. At the 3m transect mark barnacle coverage is reduced to 15% and at approximately 3.5m mark barnacles are absent. Mussels and oysters are present however they are sparse and are primarily found in the armor stone niches.

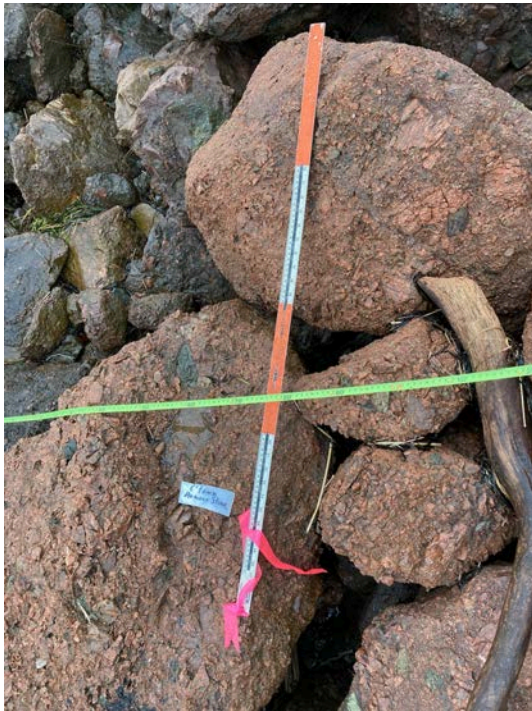
Photo 3. 5m mark on transect, near top of slope

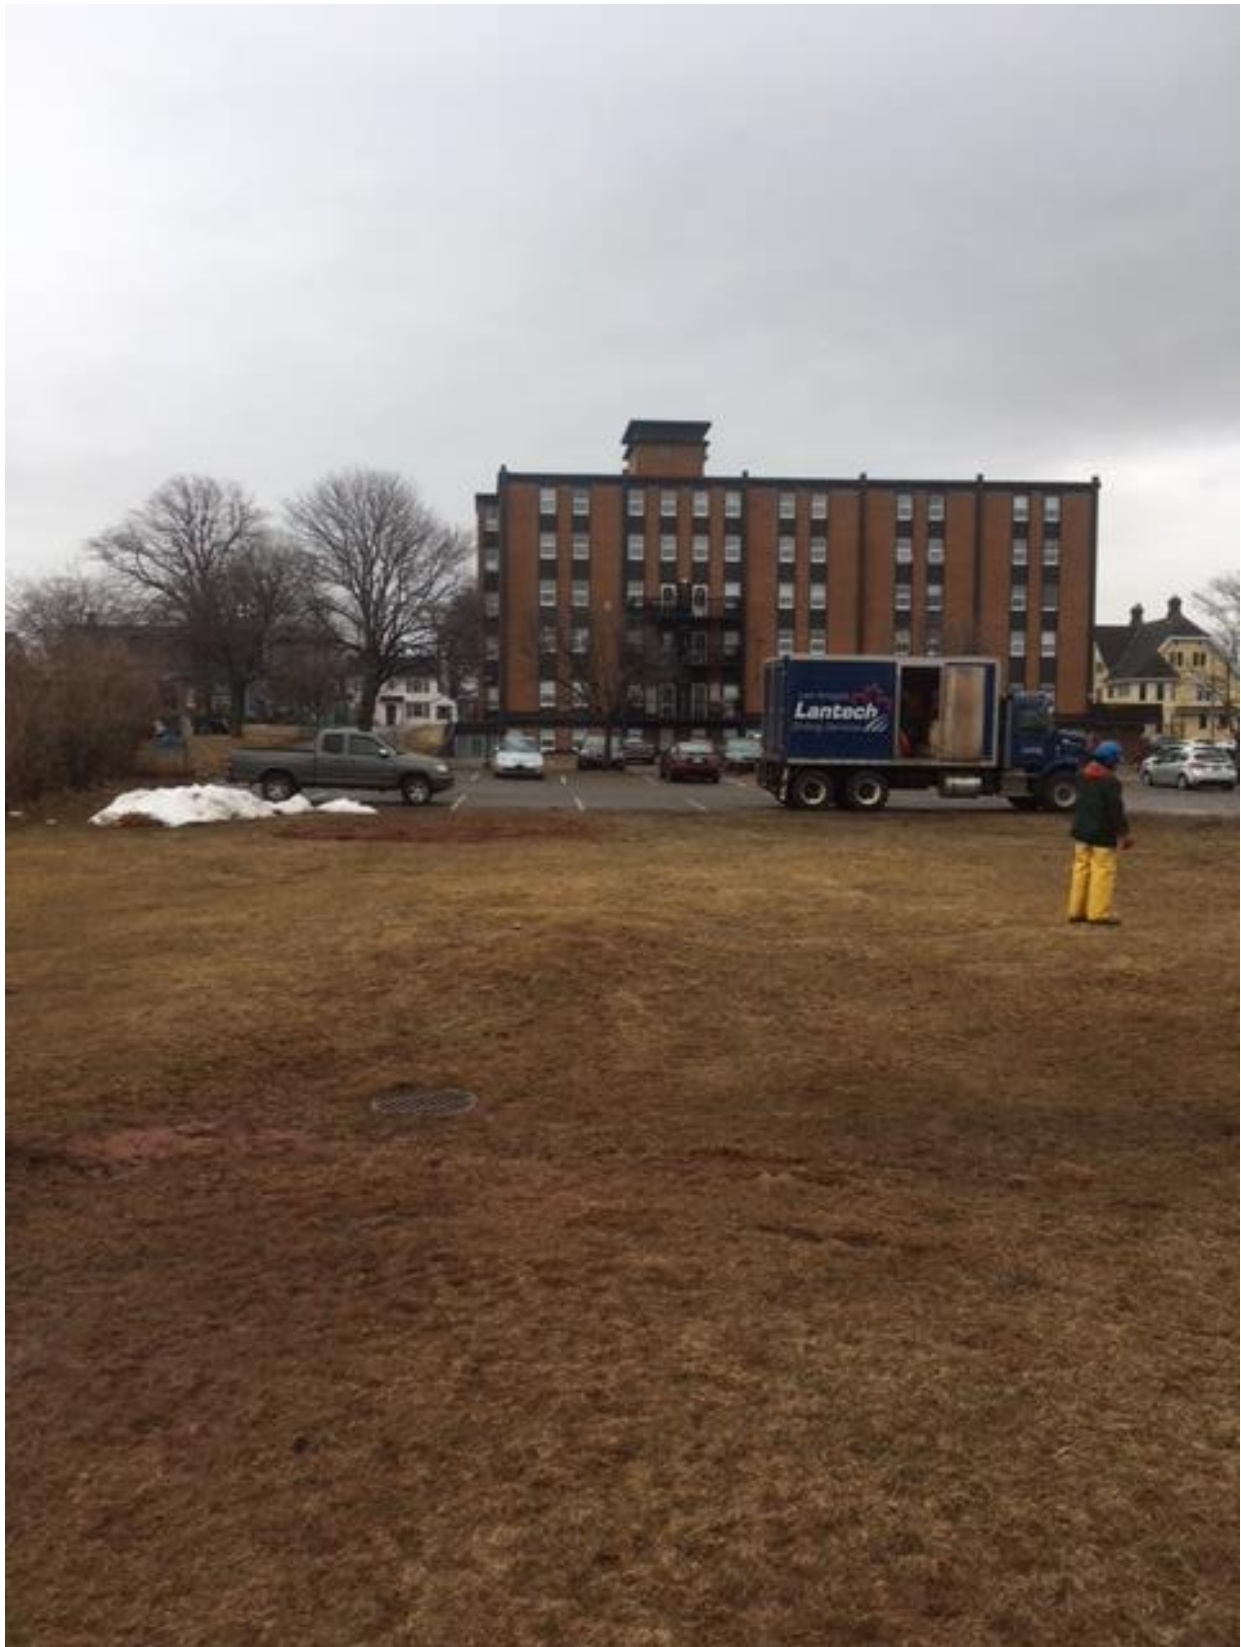
Photograph of project area facing northeast towards the existing apartment building on the site. Note the catch basin located on the left side of this image.

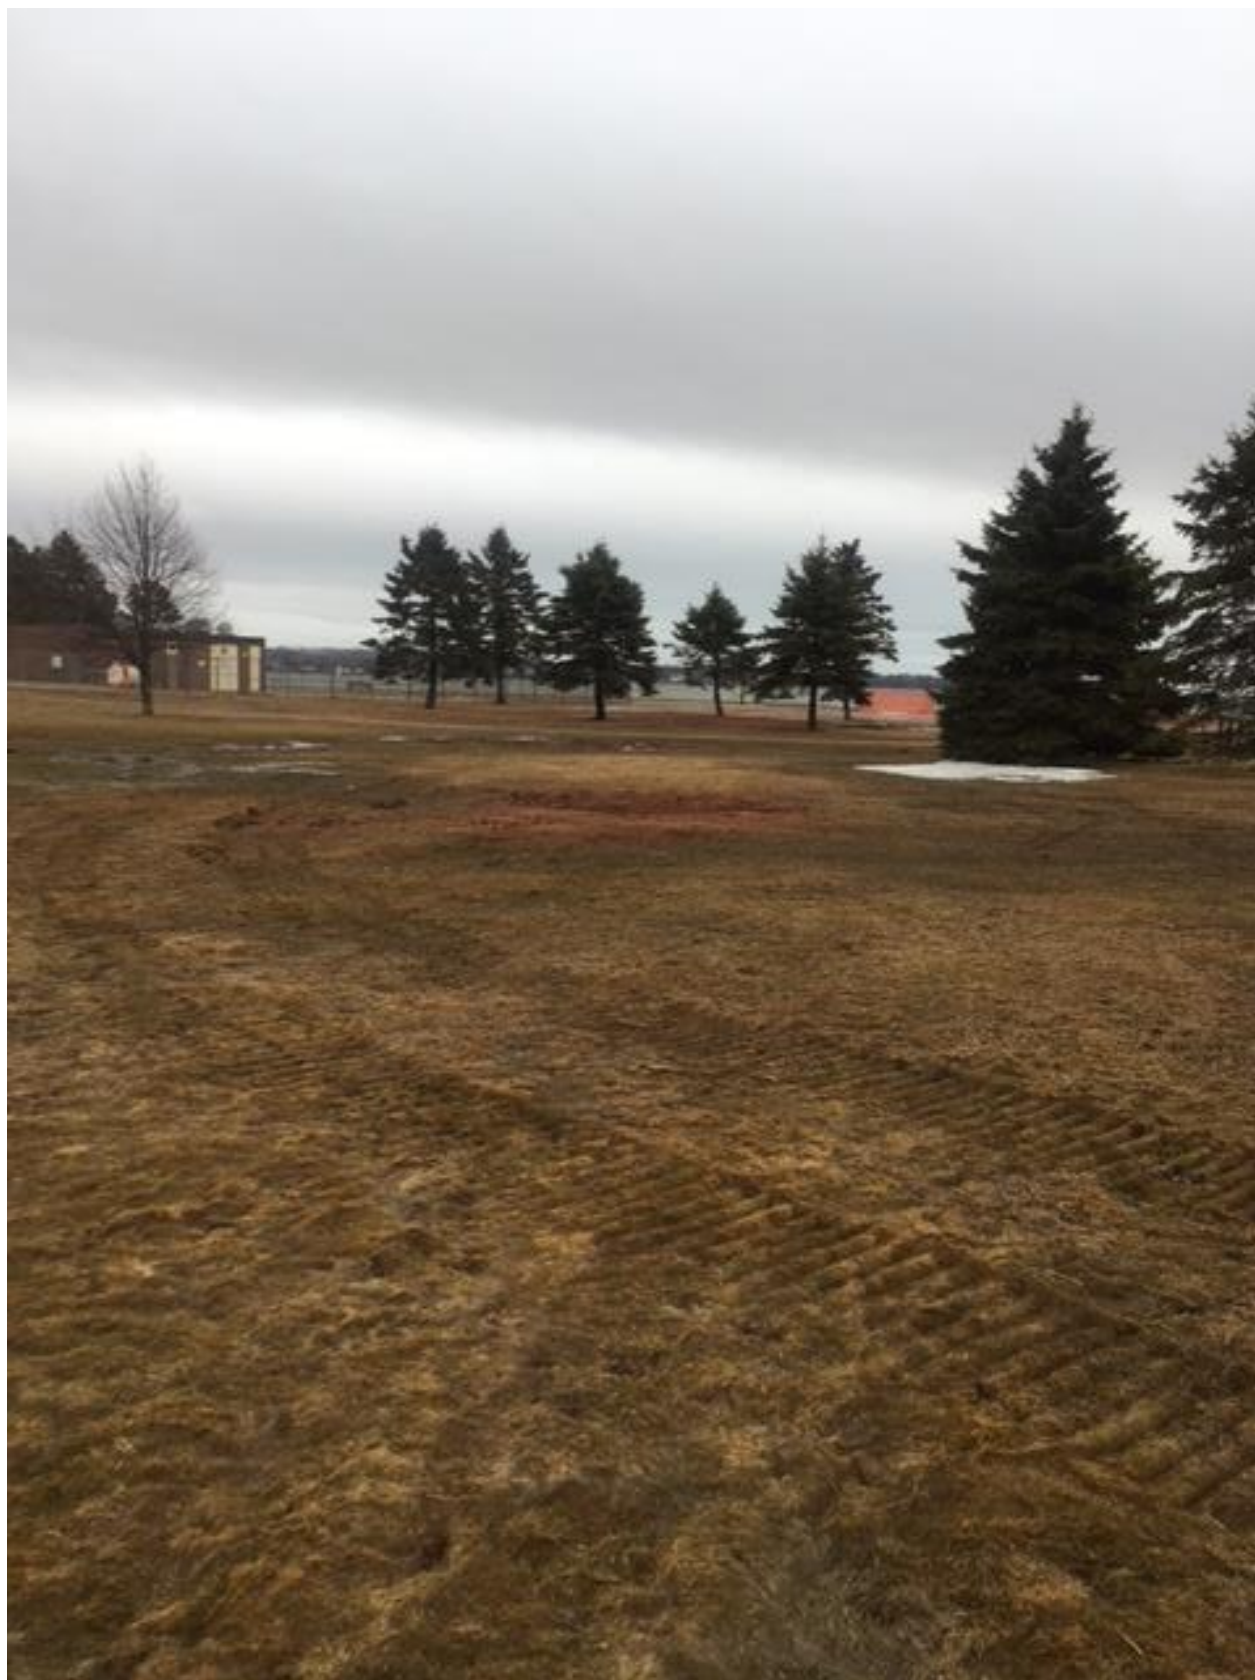
Photograph of the southwest end of the project area facing southeast.
