Decommissioning Study

Charlottetown Thermal Generation Station
50 Cumberland Street
Charlottetown, Prince Edward Island

Maritime Electric Company, Limited

11149943| Report No 4 | June 22 2018

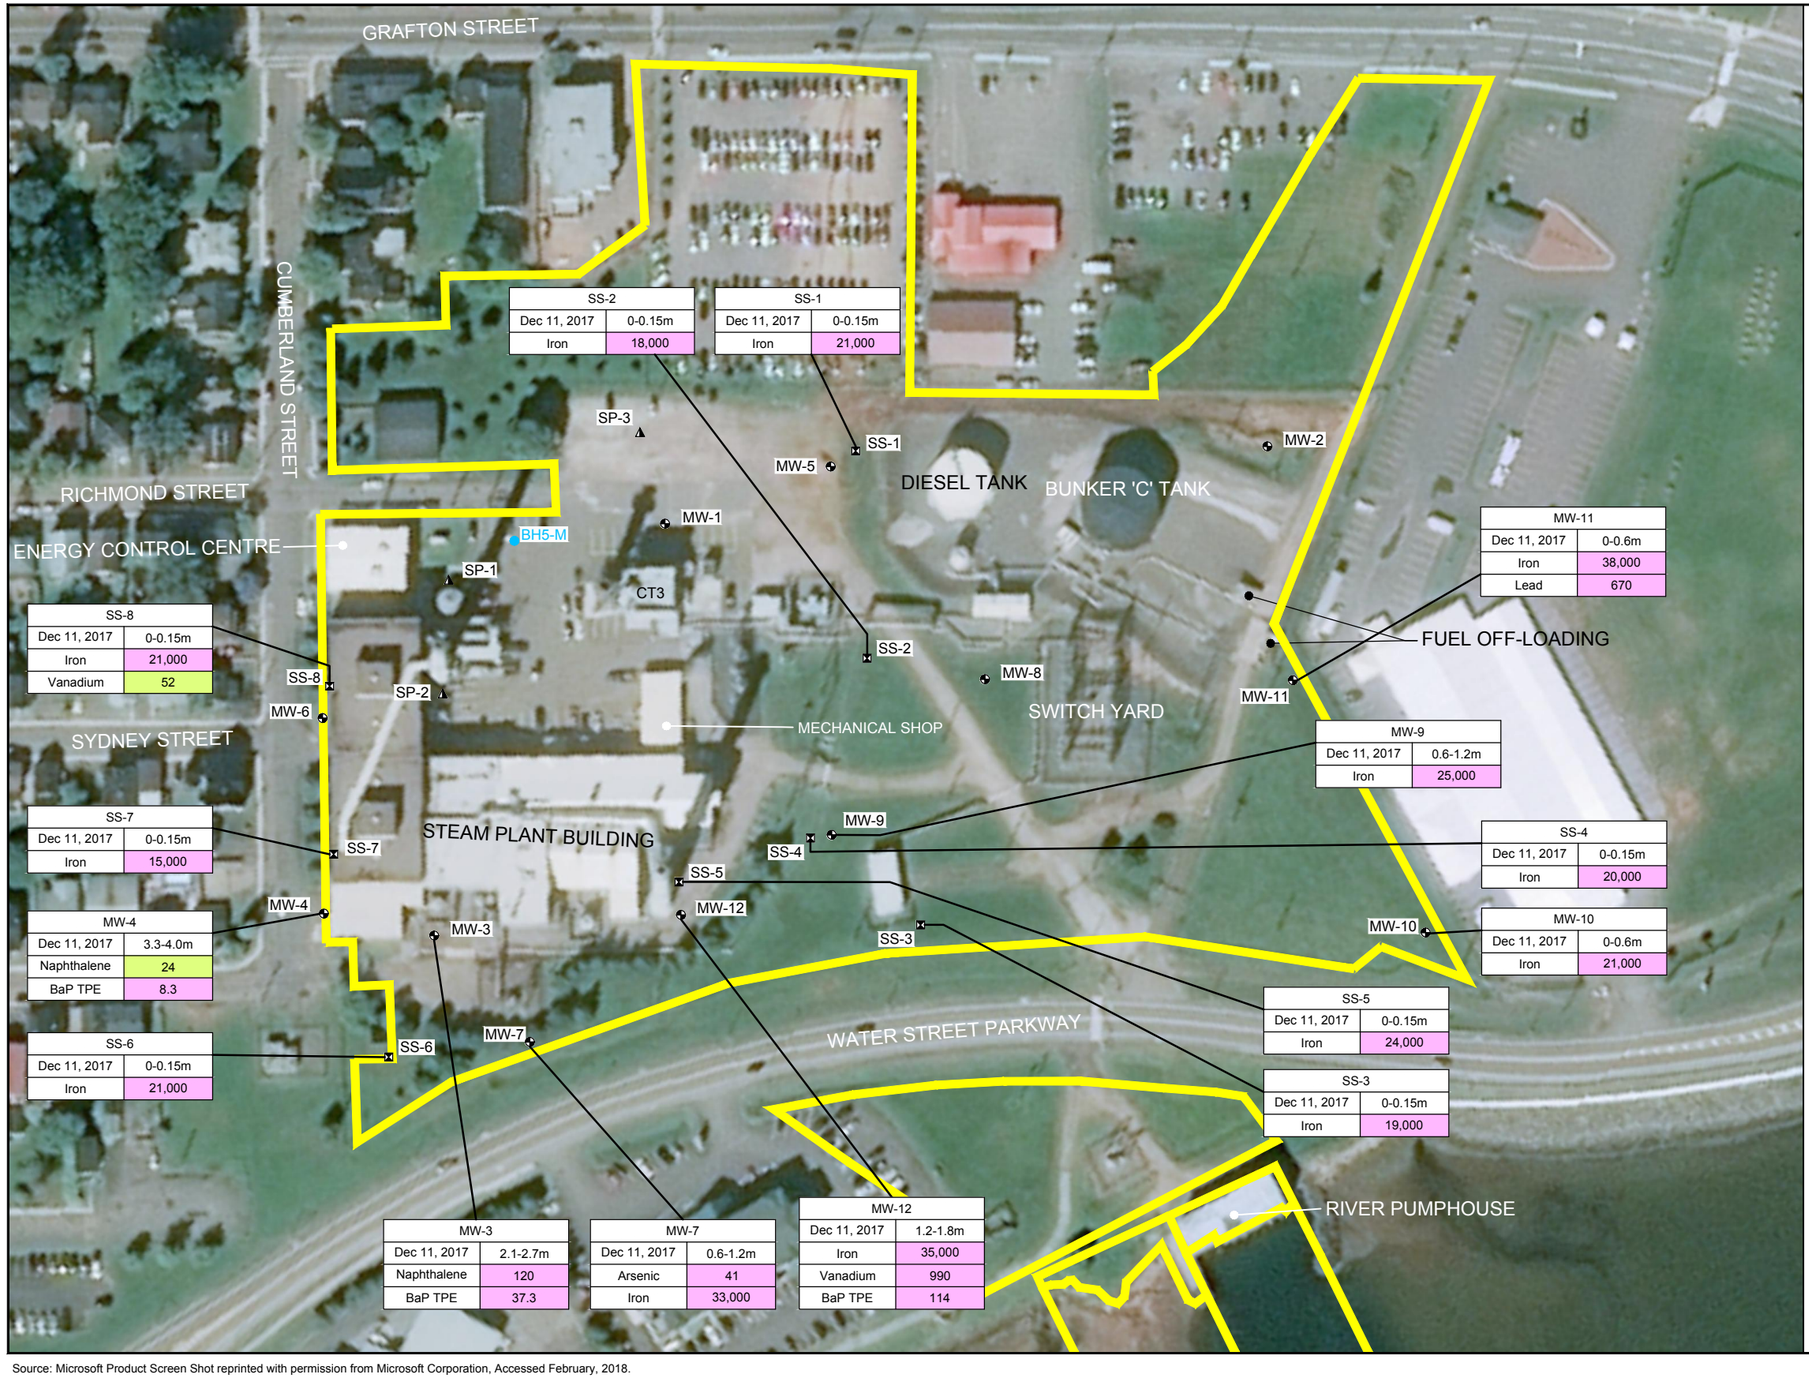
FIGURE 7B

- Paper Insulated Lead Covered (PILC) cables are electrical cables that have the potential to contain paper impregnated with PCB oils and are potentially present in numerous areas of the Site, specifically lines extending to and from the 13.8 kV and 4.16 kV switchgear (See Figures 7A and 7B).

Similarly, there are numerous electrical cables associated with the Steam Plant Building (on the interior and exterior) that have been identified as PILC cables and potentially contain oils with PCB concentrations greater than 2 mg/kg (see Figures 7A and 7B). One de-energized interior electrical cable associated with the 4.16 kV switchgear previously identified to be potentially PILC was destructively tested during the Updated Phase II ESA program completed in 2017. Results of the sampling confirmed that the free oil within the cable contained a PCB concentration of 7 mg/kg and requires specific handling and disposal as part of the recycling process. The oil impregnated paper within the cable also contained a PCB concentration of 2.8 mg/kg. Based on the data available at the time of the preparation of the Decommissioning Study, it is assumed that ten of the exterior pad mounted transformers associated with the Steam Plant Building as well as numerous electrical cables identified as PILC cables will require handling and disposal at a facility licensed to handle PCB containing equipment. Subject to verification as part of a pre-demolition survey and following de-energization of the Steam Plant Building, oil filled transformers and suspected PILC cables will require further characterization to minimize any potential wastes requiring disposal as PCB containing. An inventory of oil filled transformers and potential PILC cables at the Site is provided in Appendix D.

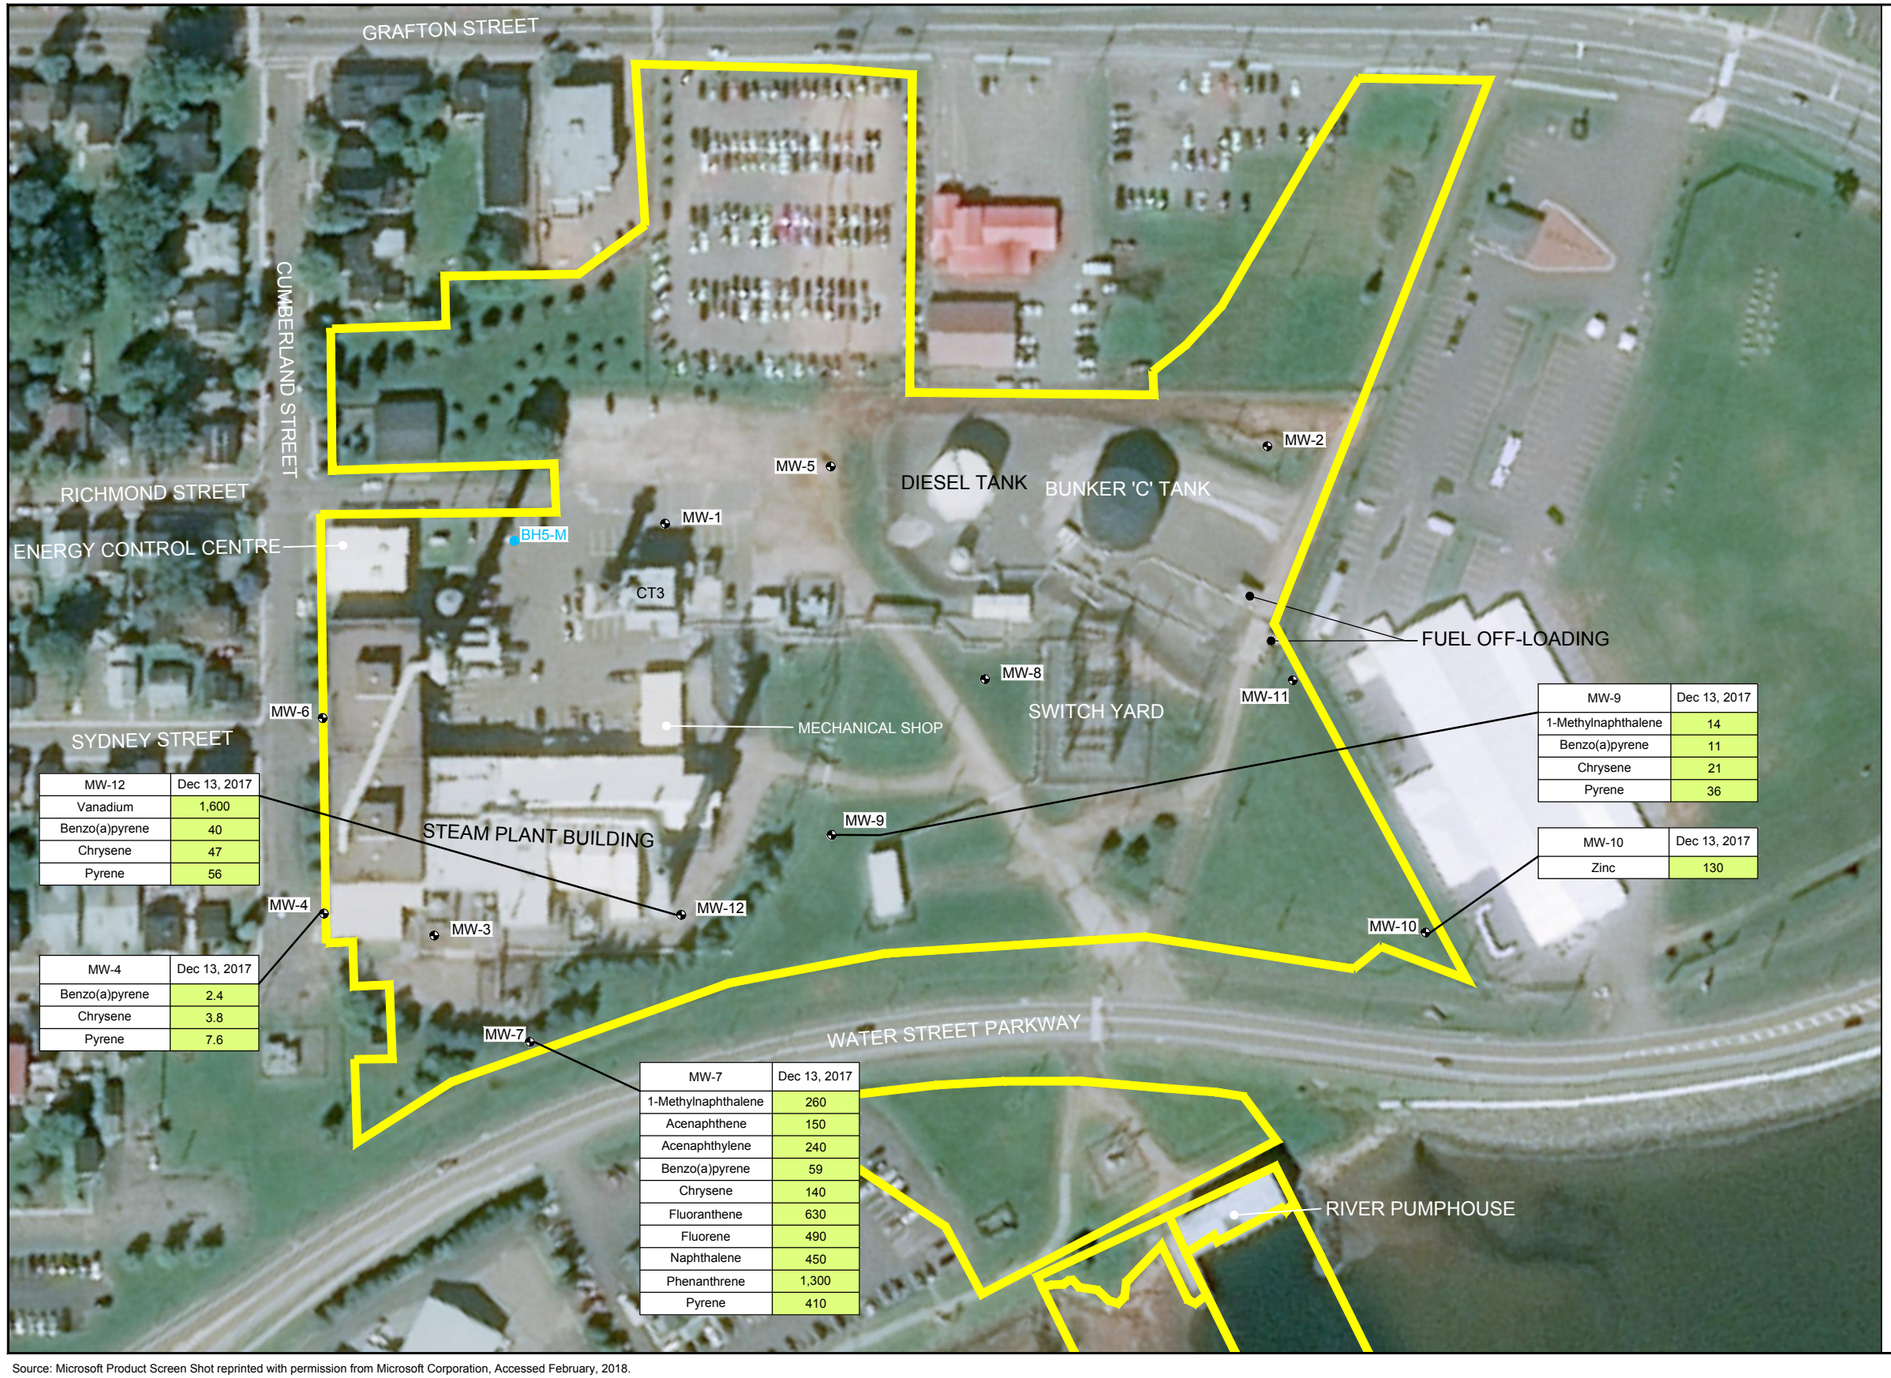
FIGURE 8A

Based on the investigations summarized above and as shown on Figures 8A and 8B, the following describes the current environmental condition of the Site that will be required to be addressed in the near future, during decommissioning or following the decommissioning activities:

It is estimated that approximately 6,000 m^3 of PAH impacted soil and groundwater exceeding applicable guidelines may be present in the southwest corner of the Site, in the vicinity of the Boiler/Turbine Zone #9, MgOH Room and Boiler Zones #4 and #5. Based on analytical data and field observations collected during the Updated Phase II ESA (GHD, 2018), the PAH impacted soil is generally confined to sub-surface soil at depths ranging from approximately 1.2 to 4.0 m below surface grade. The PAH impacts are likely related to historical facility operations (i.e. coal gasification, presence of rail lines, etc.) as current facilities generally do not generate these types of organic contaminants. The locations with concentrations of PAHs and metals in soil or groundwater exceeding applicable guidelines is shown on Figures 8A and 8B.

SOIL EXCEEDENCES (mg/kg)

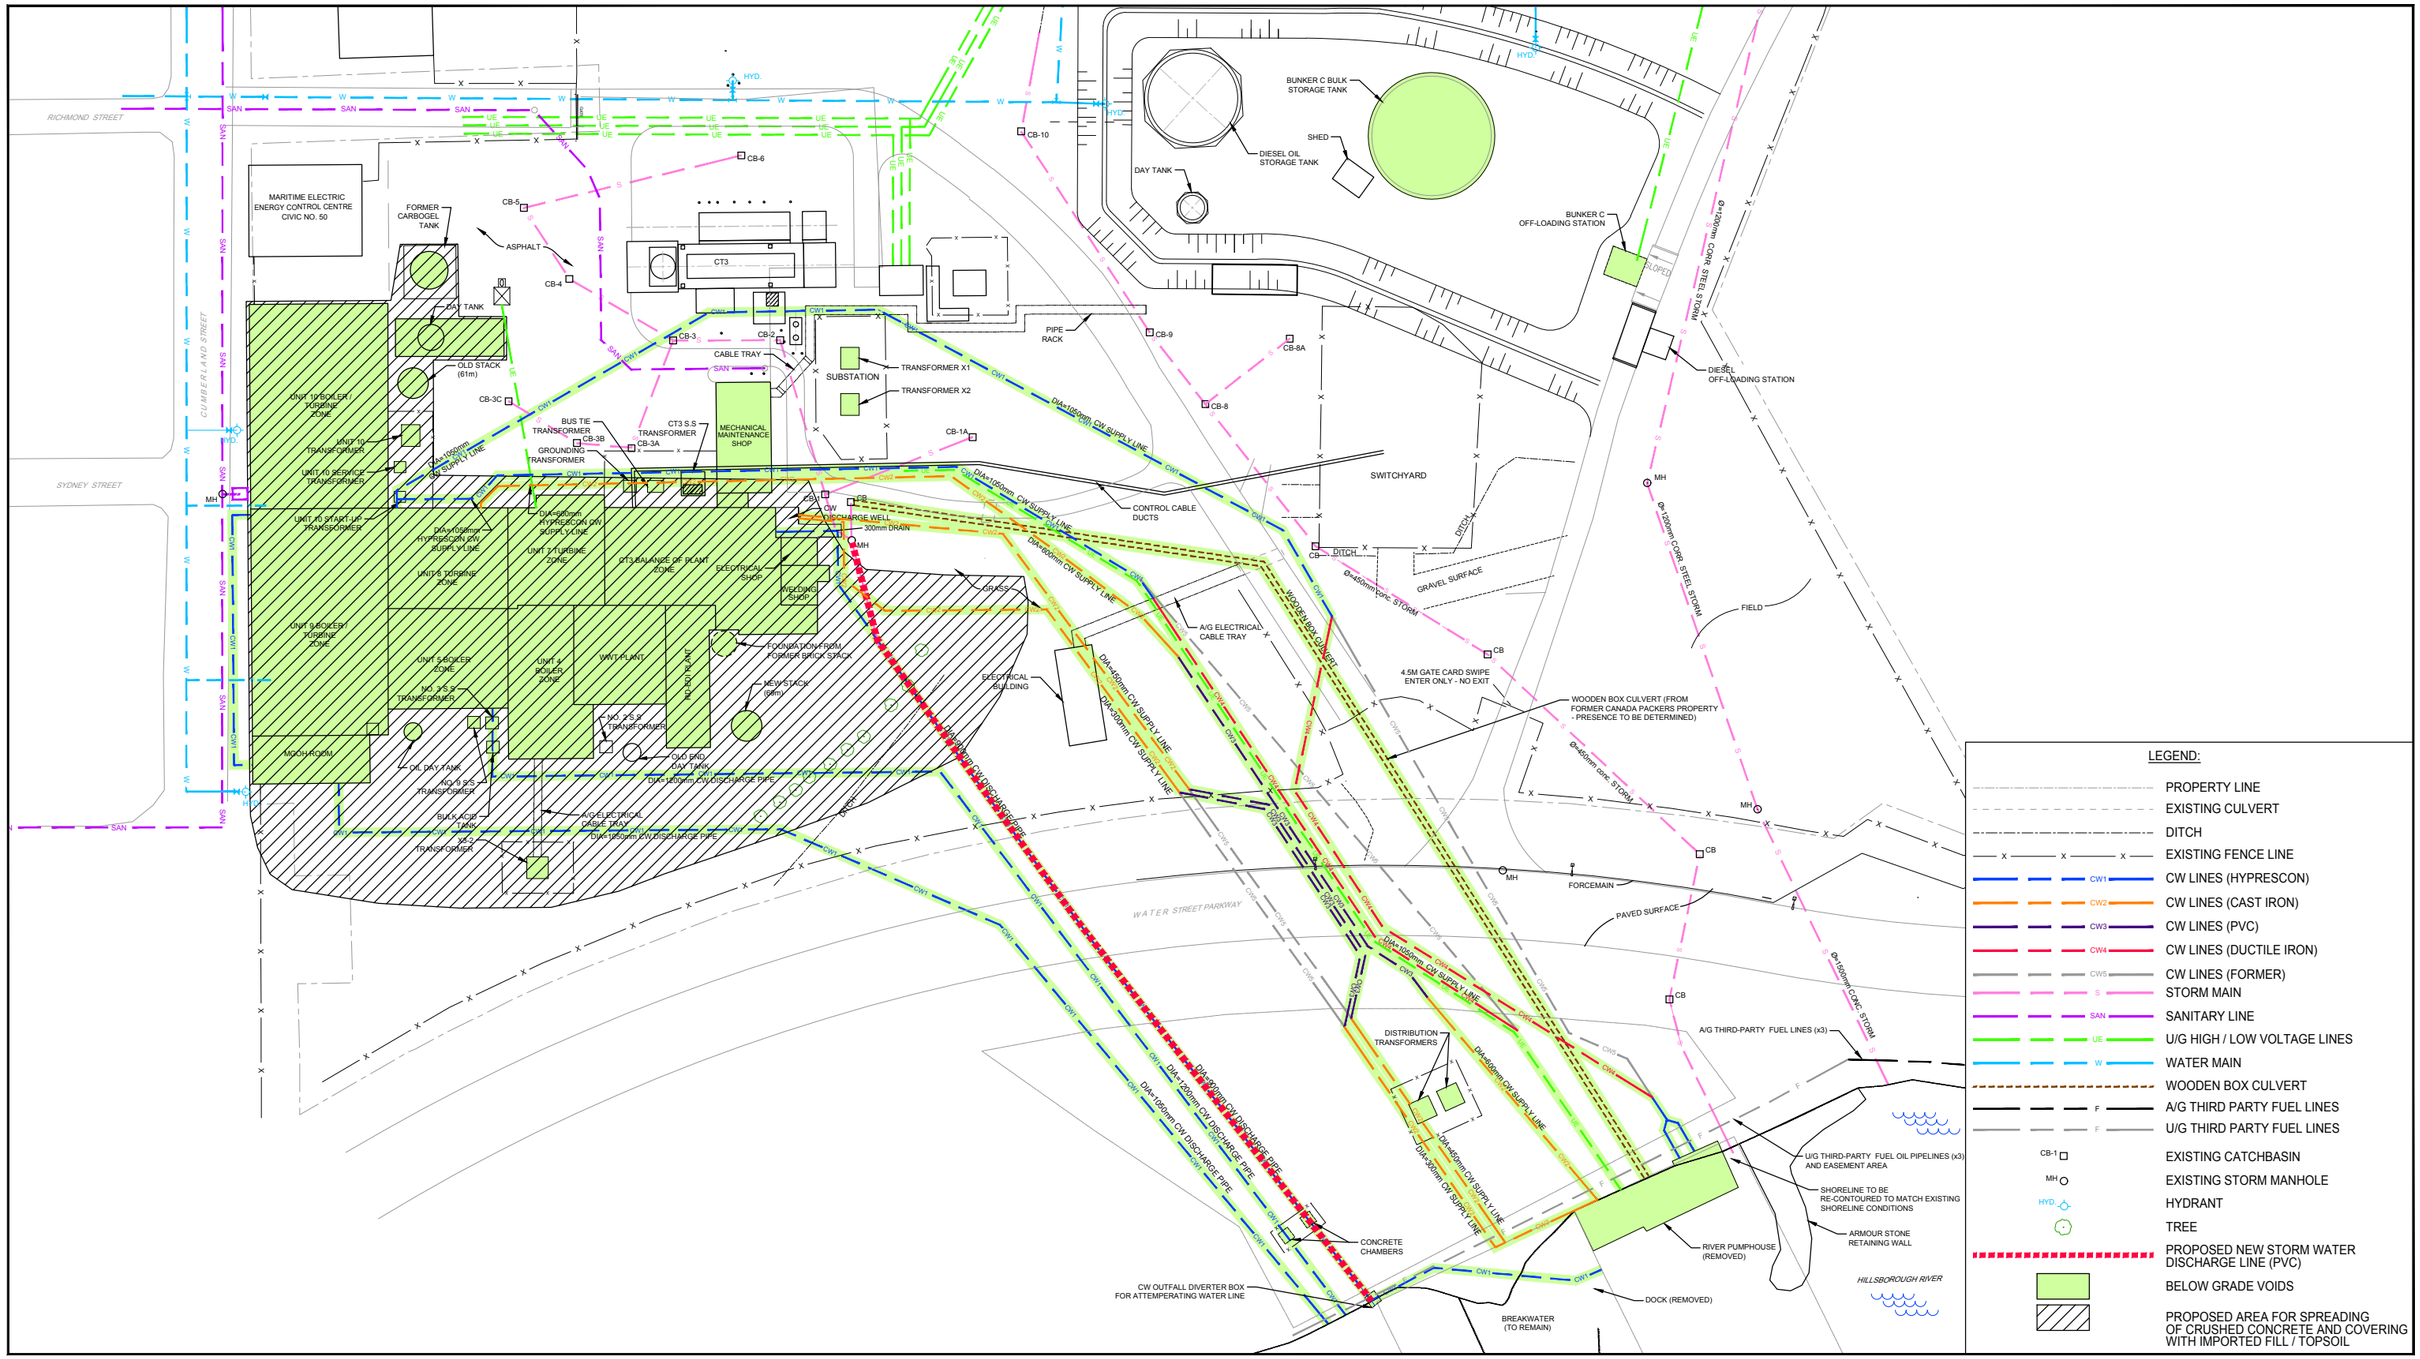
FIGURE 9

It is estimated that demolition of the Site will create void space of 4,745 m^3 as summarized in Table 4.4 (detailed calculation provided in Appendix B11). This total volume of voids includes 1,161 m^3 of voids for the CW supply and discharge piping. A portion of this void space will not require backfilling as the piping below Water Street Parkway and the petroleum pipelines adjacent to the River Pumphouse will be decommissioned using a combination of grout and plugs (see Section 5.0). Therefore, this volume has been omitted in backfilling costs in Table 9.1. Other void spaces include basements, tunnels, trenches, pits and sumps and small voids from the removals of foundation walls and slabs-on-grade. The voids created through infrastructure demolition are depicted on Figure 9.

SITE PLAN - BELOW GRADE VOIDS

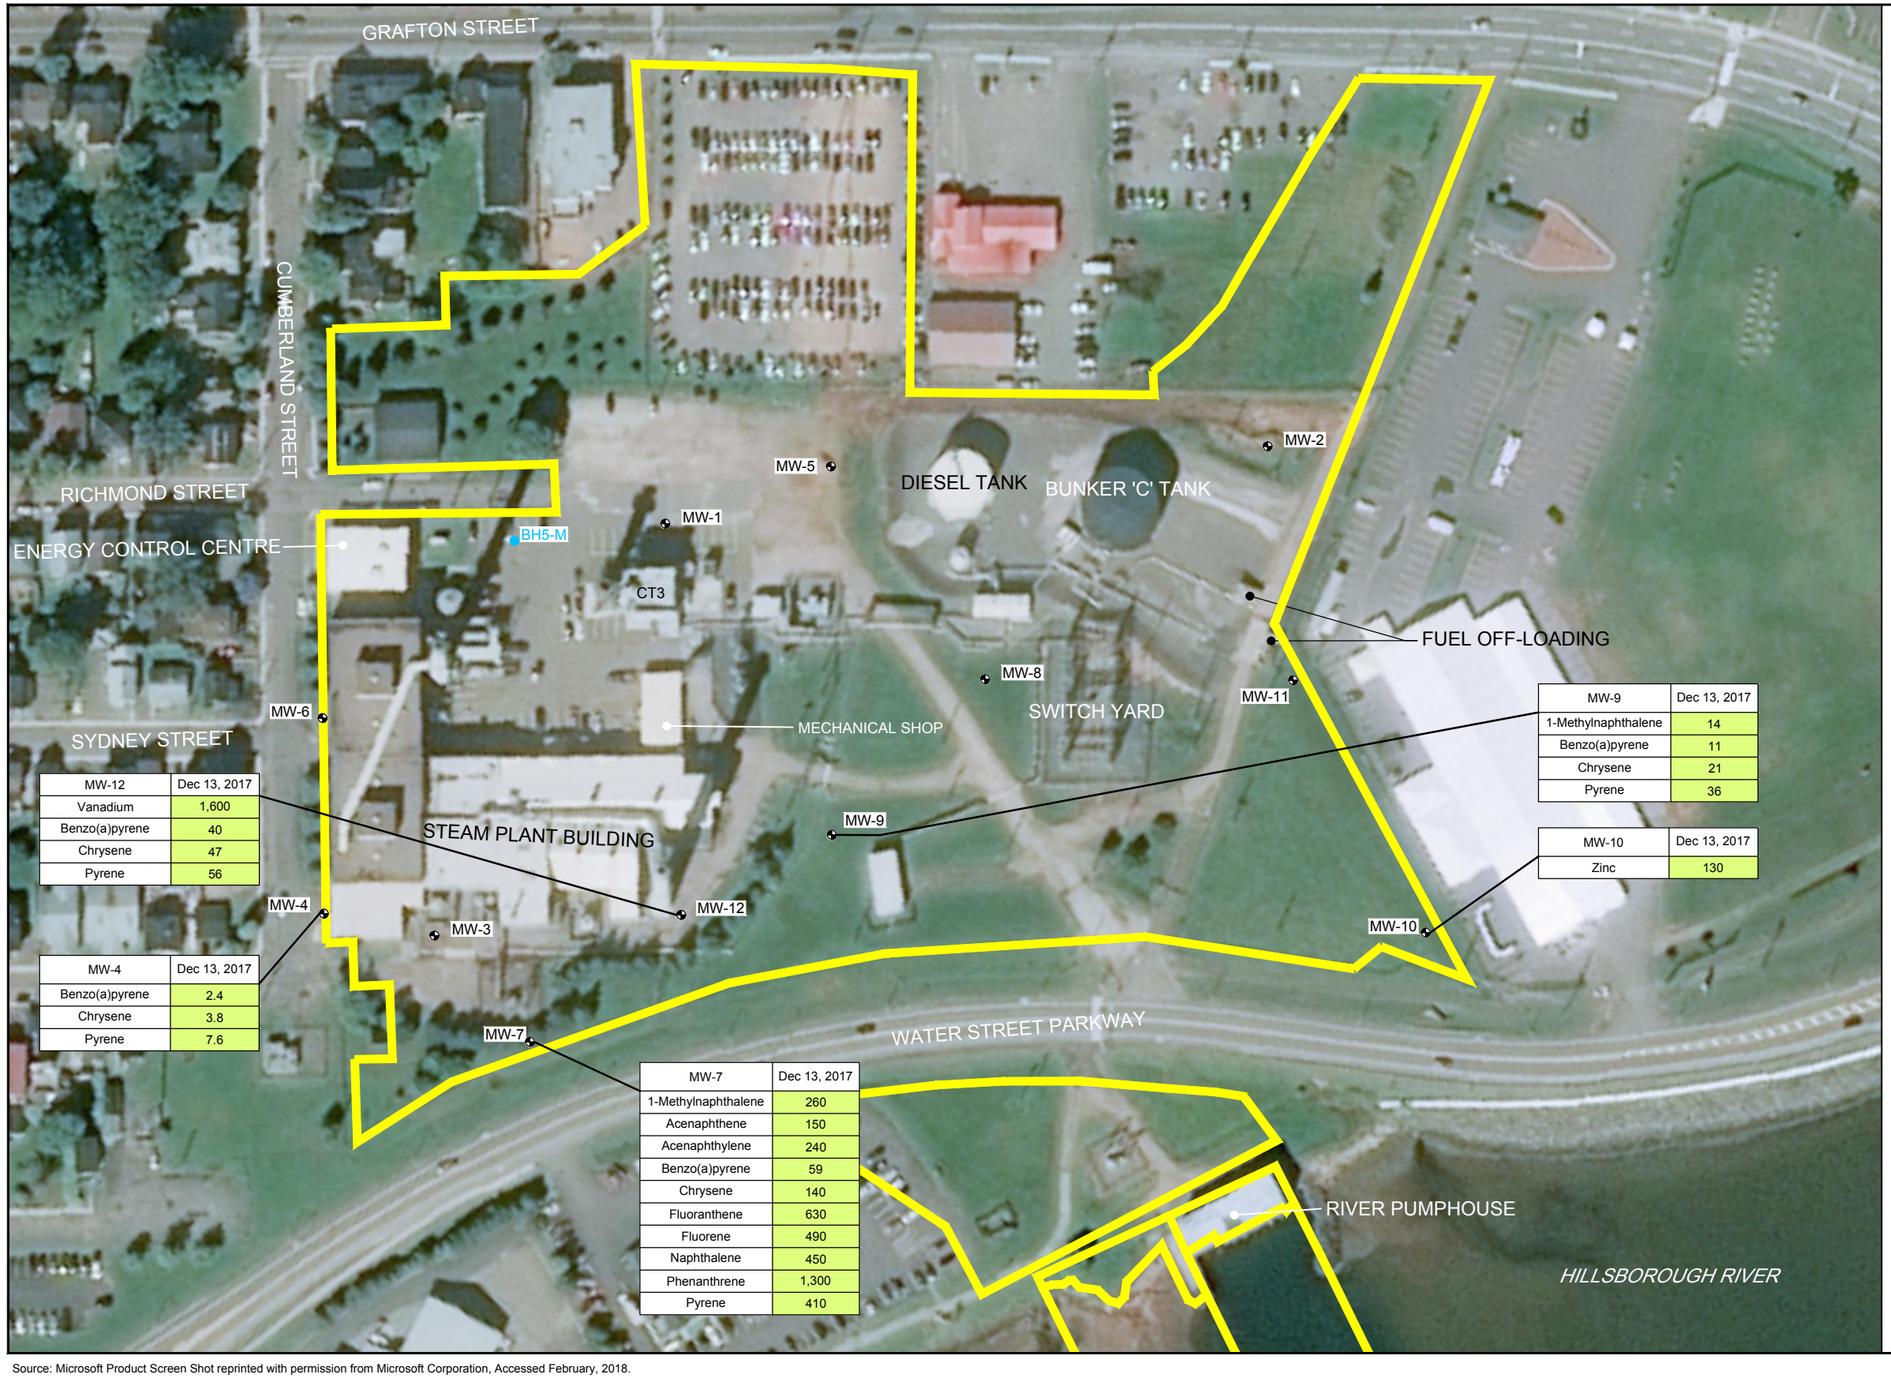
FIGURE 5

SOIL EXCEEDENCES (mg/kg)

MW-12	Dec 13, 2017
Vanadium	1,600
Benzo(a)pyrene	40
Chrysene	47
Pyrene	56

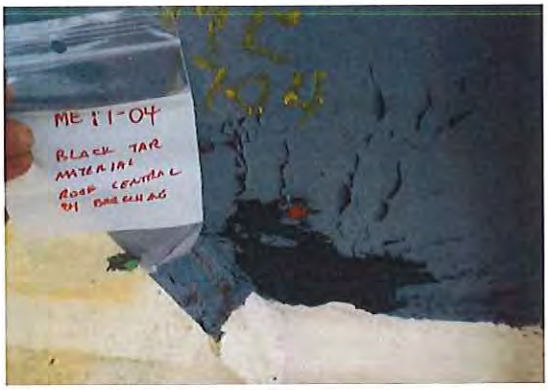
2017 Asbestos Sampling and Observations

Sample Log					Site Photo
Photo No.	Sample ID#	Location	Sample Description	Asbestos Content	
1	ME-17-01	Exterior NE Stack	Black Mastic	20 % Chrysotile	
2	ME-17-02	Exterior NE Sloped Roof	Off-White / Black Roof Material / Black Tar	N/D	
3	ME-17-03	Exterior Plexiglass Skylight on Roof	Grey Caulking	N/D	
4	ME-17-04	Exterior Central flat roof	Black tar	N/D

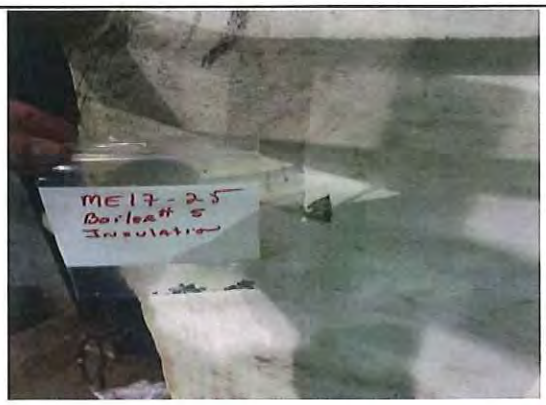
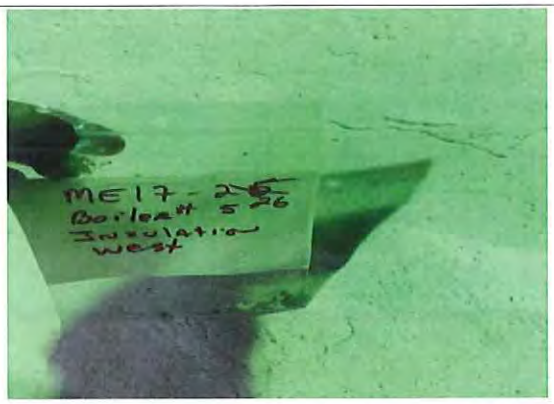
25	ME-17-25	Boiler #5 (east side)	breeching insulation	N/D	
26	ME-17-26	Boiler #5 (west side)	breeching insulation	N/D	
27	ME-17-27	Boiler #6 (west side)	breeching insulation	N/D	
28	ME-17-28	Boiler #6 (east side)	breeching insulation	N/D

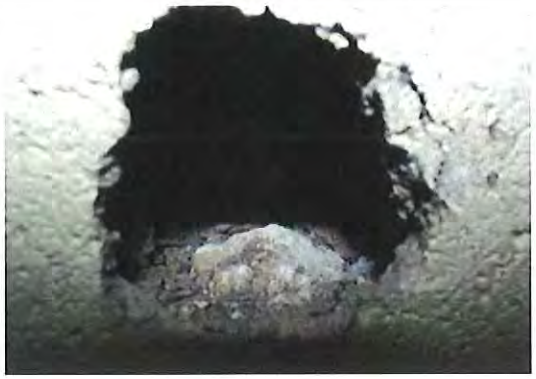
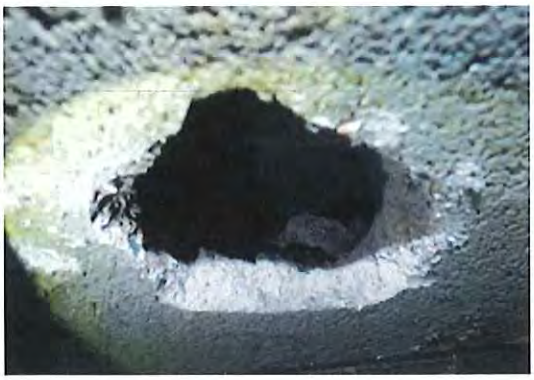
29		Behind #5 Reserve Tank	Nothing Observed inside Block Wall		
30		Behind #10 Reserve Tank	Nothing Observed inside Block Wall		
31		West Wall #10 Boiler	Nothing Observed inside Block Wall		
32		North Wall By Shop	Nothing Observed inside Speed tile

33		Exterior Bunker C Tank	Steel casing (no insulation observed)		
34		Boiler # 6 Speed Tile Wall	Nothing Observed inside Speed tile		
35		Boiler # 6 Speed Tile	Nothing Observed inside Speed tile		
36		Top of Exterior Bunker Tank	Steel casing (no insulation observed)

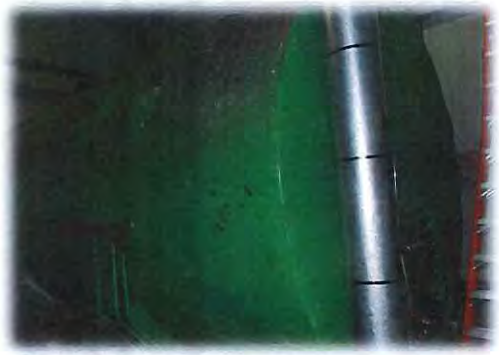
Unit / Boiler: No. 10 Boiler / ACM Hardboard / Transite						
DESIGN	**DESCRIPTION**	**LOCATION**	**Est. Quantity**	**Units**	**ASBESTOS CONTENT**	**Site Photo**
Wall	Transite Panel	Deaerator Level	21	m^2	35% Chrysotile (ME-033)	
Wall	Corrugated Transite Panel	Turbine Level - No. 10 turbine side next to No. 9 Turbine	227.6	m^2	35% Chrysotile (ME-033)

Wall	Corrugated Transite Panel	Ground Level - No. 10 turbine side next to No. 9 Turbine	61.3	m^2	35% Chrysotile (ME-033)	
Total est. qty.			**309.9**	**m^2**		
Comments:

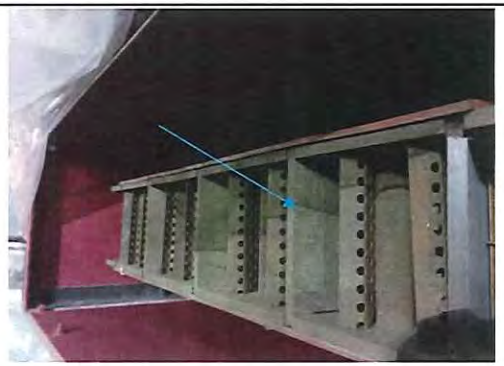
Unit / Boiler: No. 10 Boiler / Turbine Pipe Insulation

DESIGN	DESCRIPTION	LOCATION	Est. Quantity	Units	ASBESTOS CONTENT	Site Photo
Pipe	Main Line underneath HLRTK10 (12" diameter)	Deaerator Level	0.3	m	80% Amosite (ME-069)	
Pipe	HP Steam pipe insulation (18" diameter)	1st platform (south end)	9	m	80% Amosite (ME-069)	
Total est. qty.			**9.3**	**m**		
Comments:

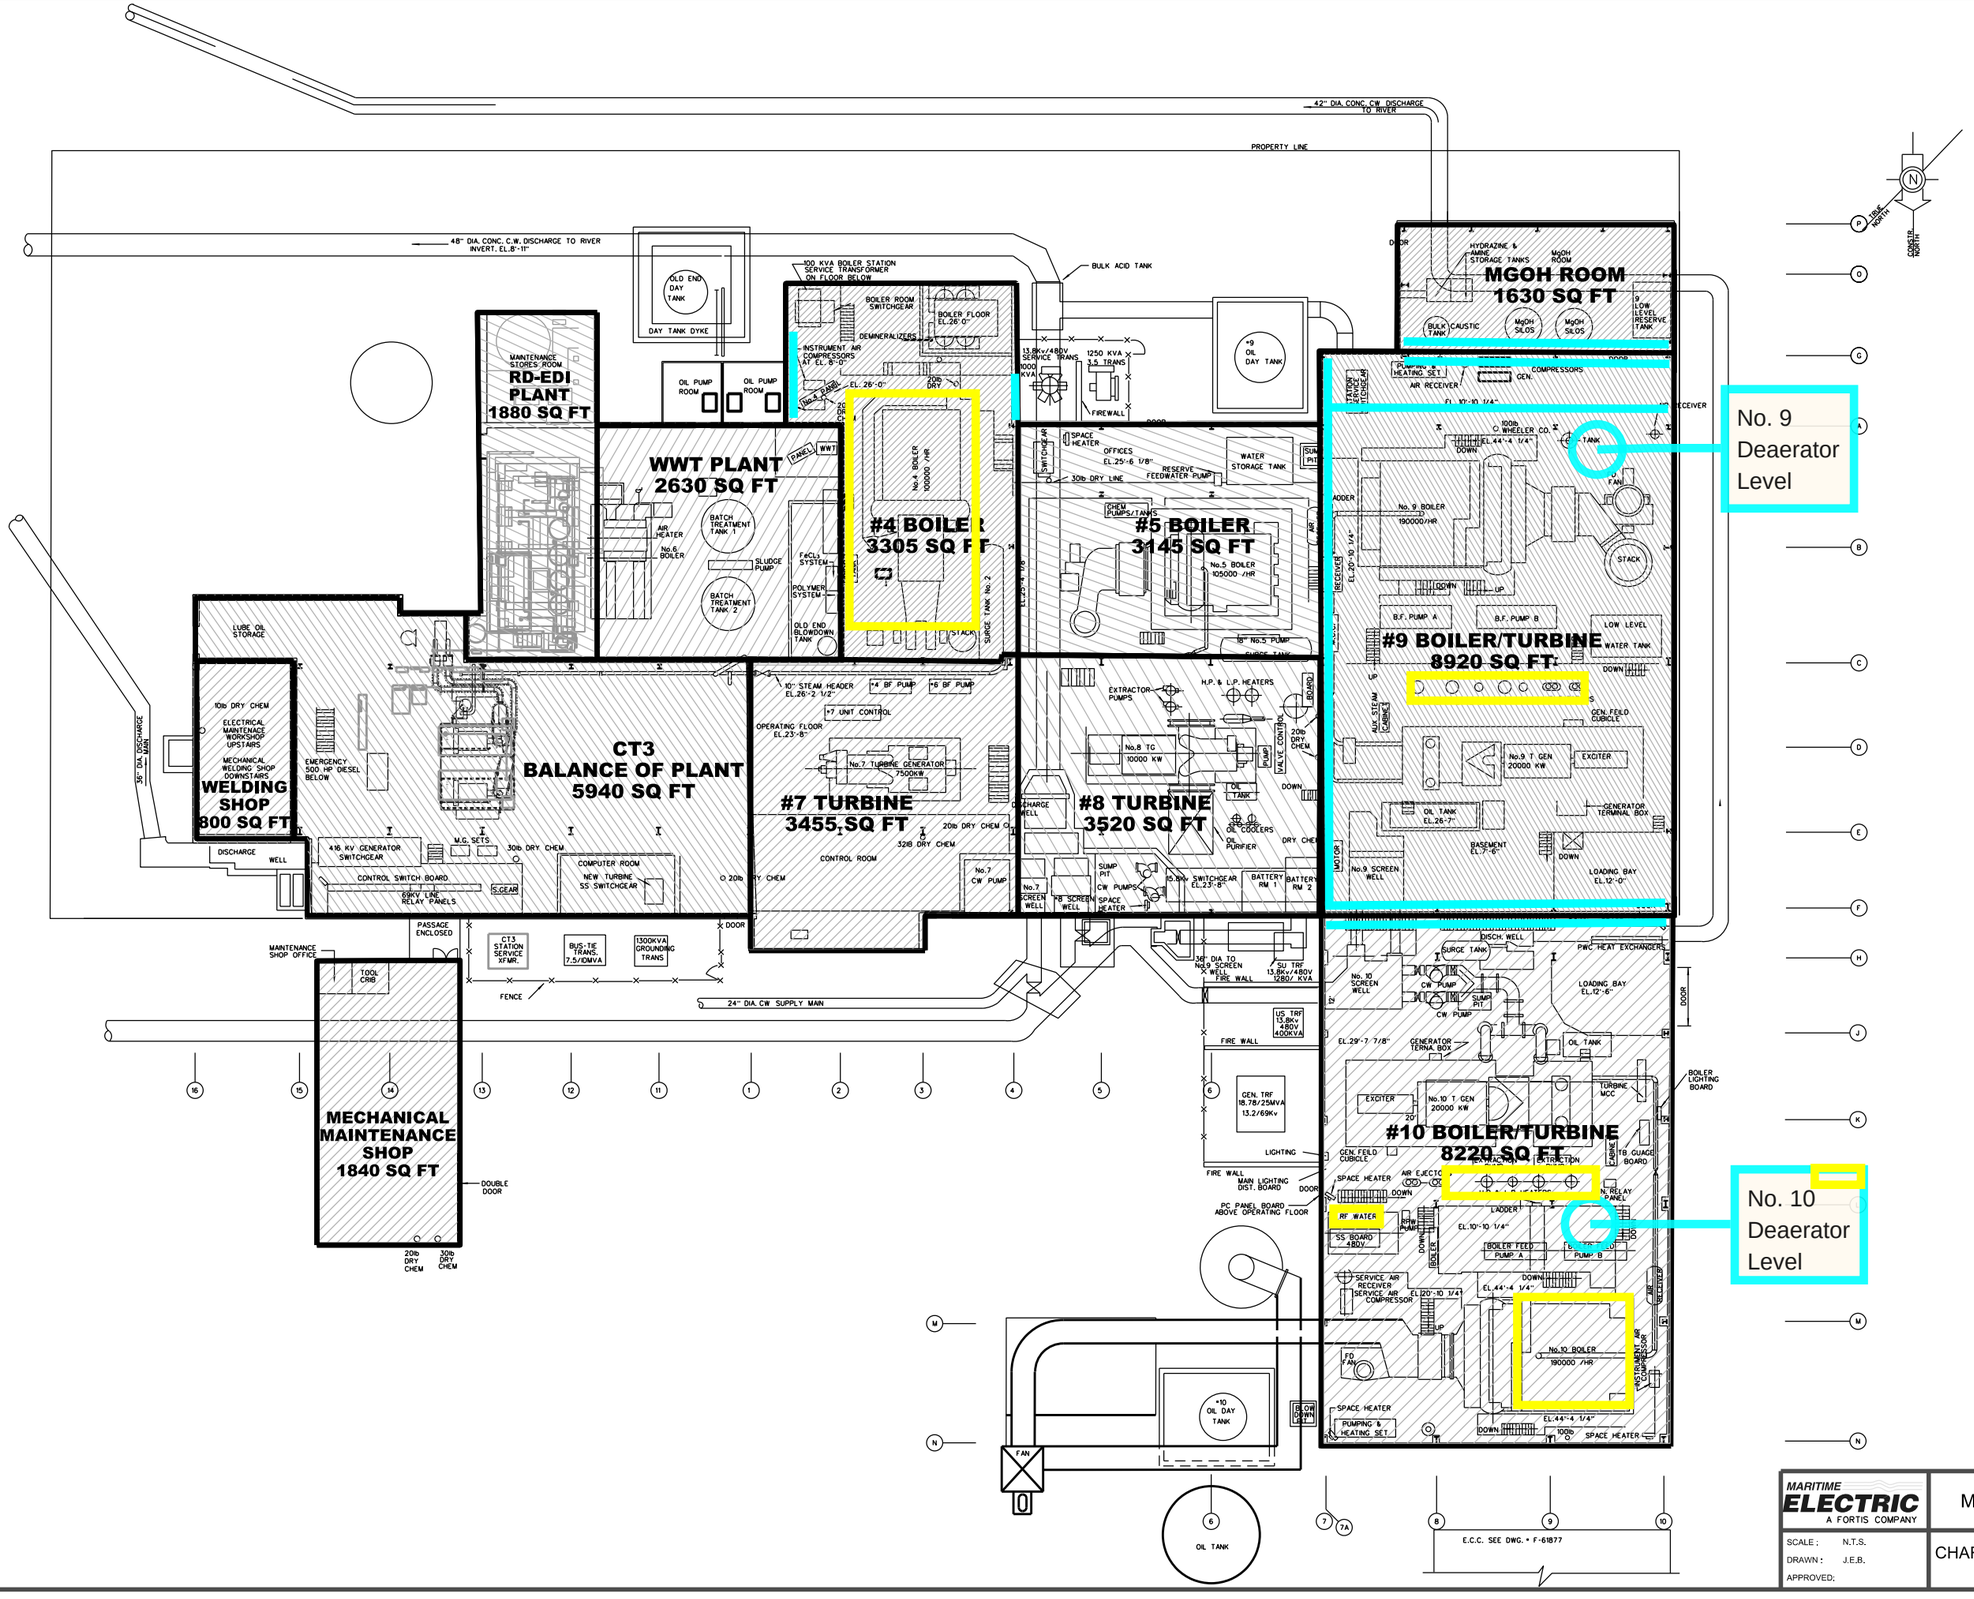
Site Drawing with ACM Concentration Areas

MGOH ROOM
1630 SQ FT
RD-EDI PLANT
1880 SQ FT
WWT PLANT
2630 SQ FT
#4 BOILER
3305 SQ FT
#5 BOILER
3145 SQ FT
#9 BOILER/TURBINE
8920 SQ FT:
CT3
BALANCE OF PLANT
5940 SQ FT
WELDING SHOP
800 SQ FT
#7 TURBINE
3455 SQ FT
#8 TURBINE
3520 SQ FT
MECHANICAL MAINTENANCE SHOP
1840 SQ FT
#10 BOILER/TURBINE
8220 SQ FT
No. 9 Deaerator Level
No. 10 Deaerator Level
Legend
ACM transite / hardboard panels concentrated areas
ACM mechanical insulation concentrated areas
MARITIME ELECTRIC COMPANY, LIMITED
A FORTIS COMPANY
CHARLOTTETOWN STEAM PLANT ZONES
SCALE : N.T.S.
DRAWN : J.E.B.
APPROVED:
DATE : SEPT 13, '96
REVISED : JUNE 23, '17
DWG. No. : G-96-05
