# **MARITIME ELECTRIC**

# **CHARLOTTETOWN GENERATING STATION**

## **STUDY**

PERFORM AN ANALYSIS ON THE REQUIREMENTS TO OPERATE THE GENERATING UNITS IN A SAFE MANNER TO THE END OF 2018

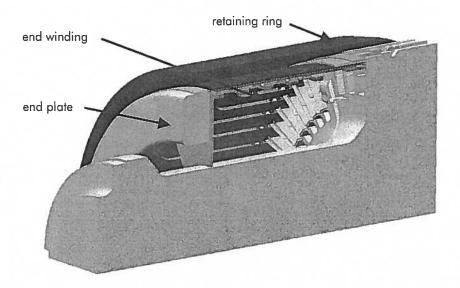
The main function of the retaining ring is to retain the field windings. These windings extend beyond the main body of the rotor at each end of the generator and during operation exert a high centrifugal force on the retaining rings. This results in the retaining ring being a significantly stressed generator component.

Figure 1: cutaway view of a retaining ring and end winding

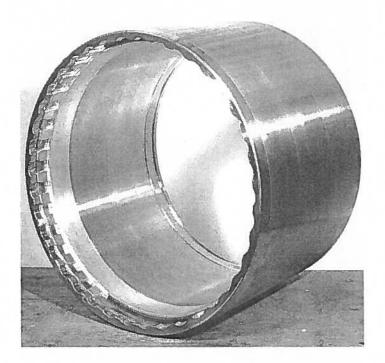
After the problems experienced with the old steels, a new alloy steel, X8CrMnN1818 was developed which exhibits much better resistance to Stress Corrosion Cracking. It is the best material available today in terms of strength, toughness and pitting resistance. Service experience with this material is very positive. The industry quickly changed to the new retaining ring material when it became available.

Figure 2: New steel retaining ring
